## TERMITE - SITE ASSESSMENT & ADVICE

**Site Address:** 32 Princes Street Hunters Hill NSW 2110

**Report Type:** Pest Inspection Report

**Date of Inspection (s):** 25/10/2021 & 28/10/2021

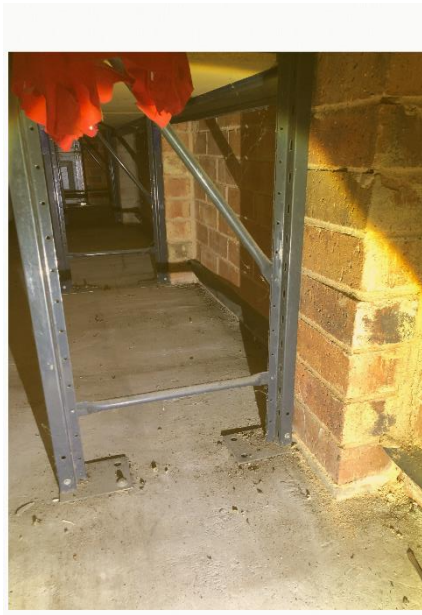
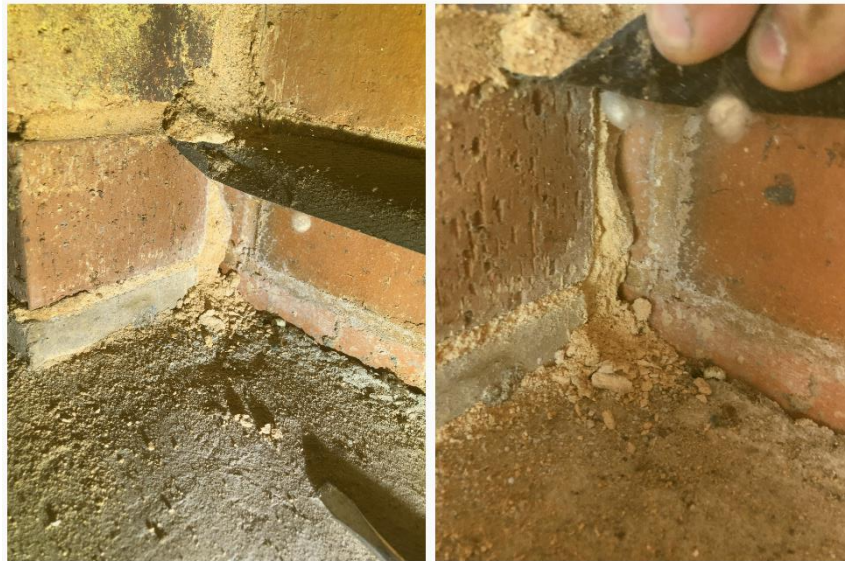
5. Second possible termite entry point into the garage was within the third brick pillar along the left side of the garage approx. 5 m from the garage door.

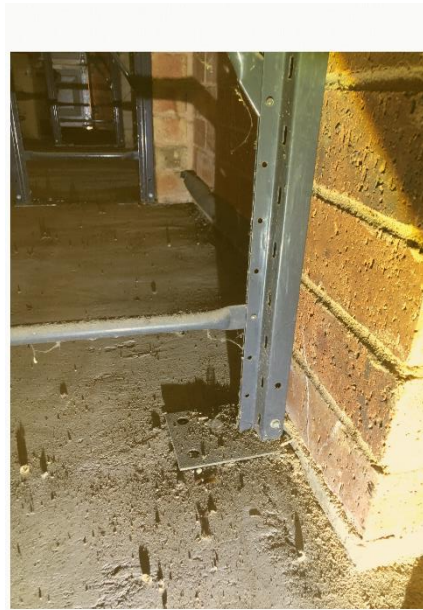
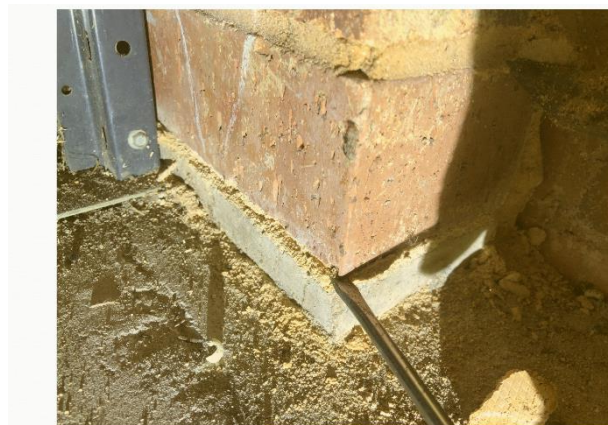
6. The entire bottom brick mortar is deteriorating.

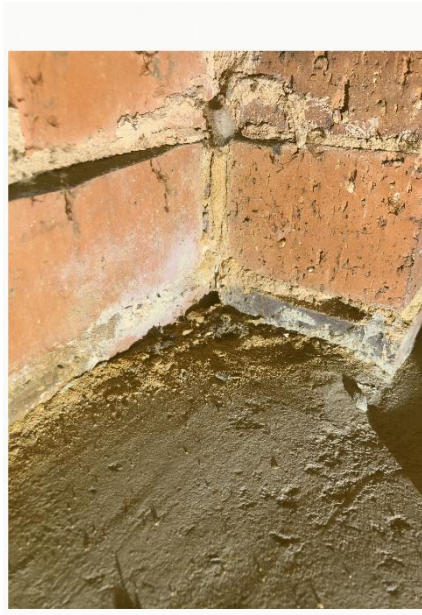
7. The rear wall of the garage engaged brick pier, to the left side of the rear door, there is sand and light mud tunnels found in the floor and wall junction and engaged pier junction.

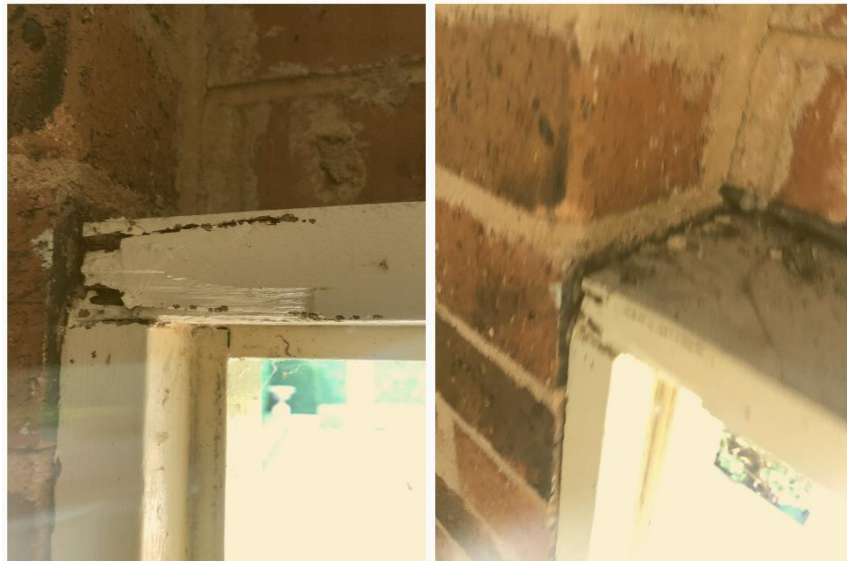
8. The rear garage door, single leaf door and doorjamb has termite damage within the doorjamb head piece.

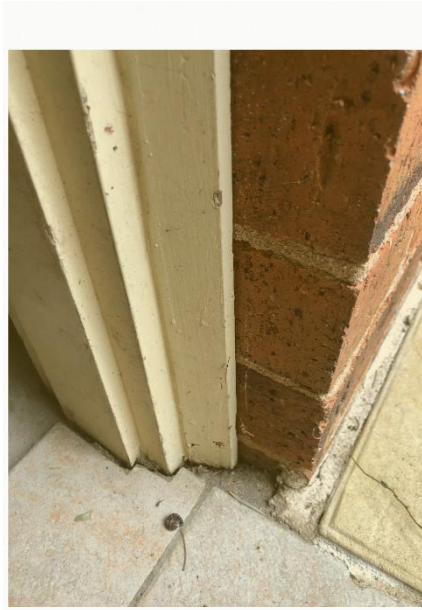
9. Garage doorjamb style is loose and wobbly at the base where the left garage doorjamb meets the garage floor and outside floor tiles.

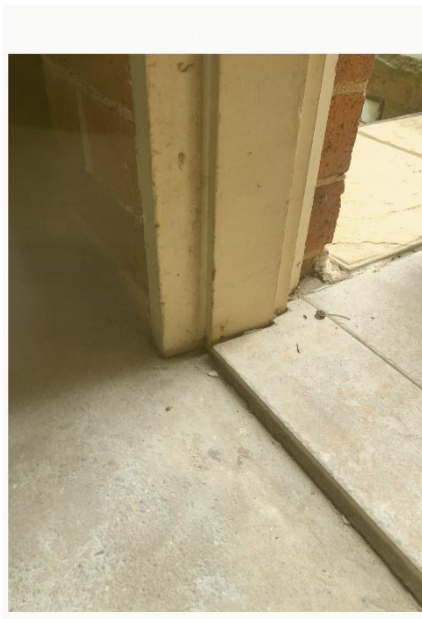
10. No mud tunnelling found but this is adjacent to the pier where the mud tunnelling was found, timber jamb could be affected by wood rot or concealed termite damaged behind the doorjamb.

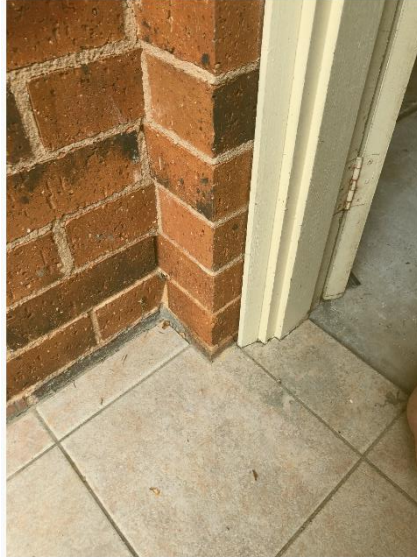
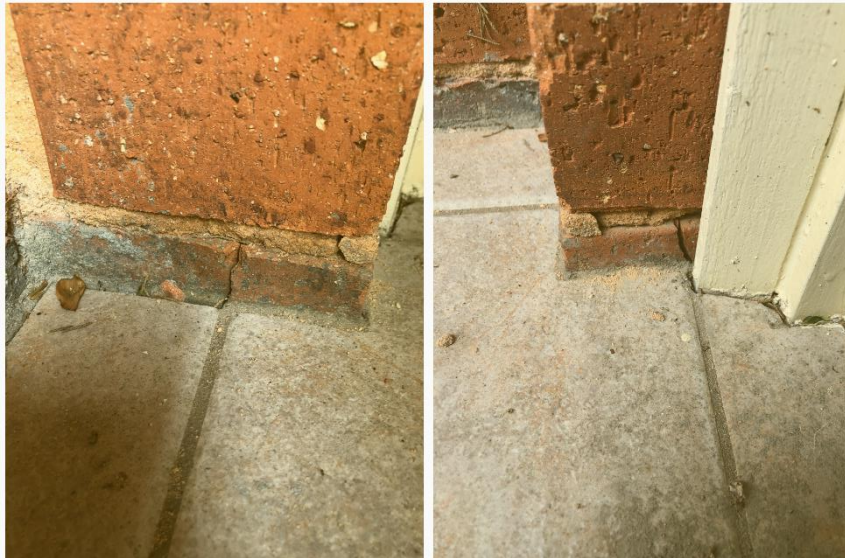
11. The garage rear single leaf doorjamb has cracked face brickwork, the crack goes through the body of the brickwork above ground and within the subterranean level, this is a concealed entry point for termites.

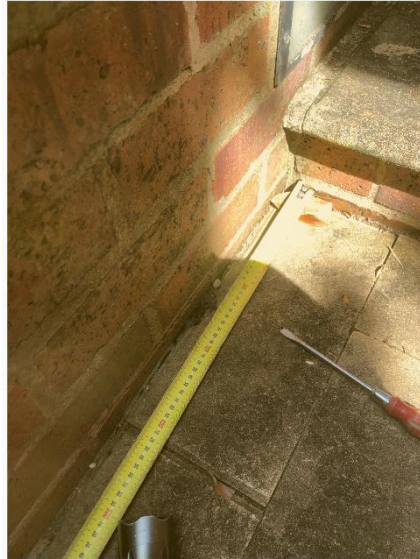
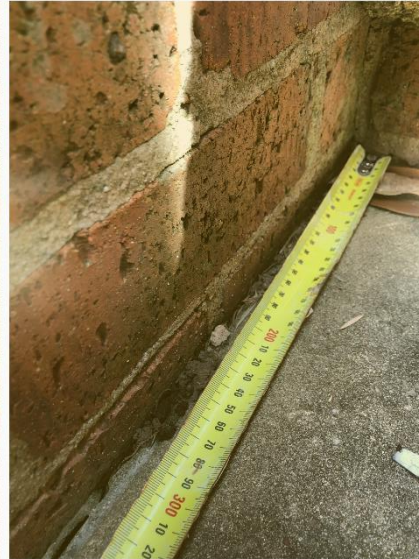
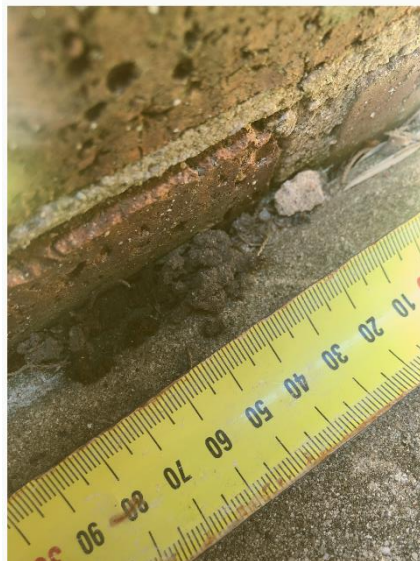
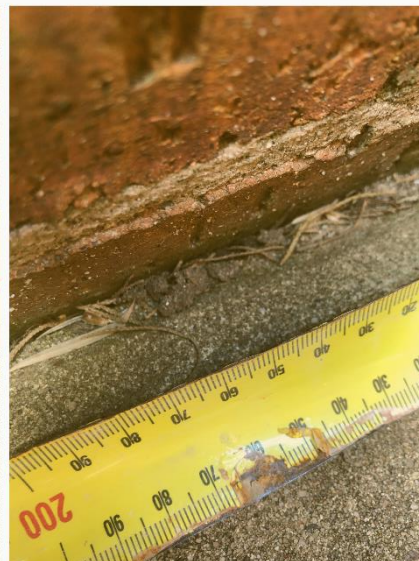
12. Within the rear elevation of the garage, there is a three-step staircase within the landing, prior to the first step on the left-hand side there is a small mud tunnel located between the external floor pavers and face brickwork, this mud tunnel is found in two locations: approximately 150 mm from the step riser and 300 mm from the step riser.

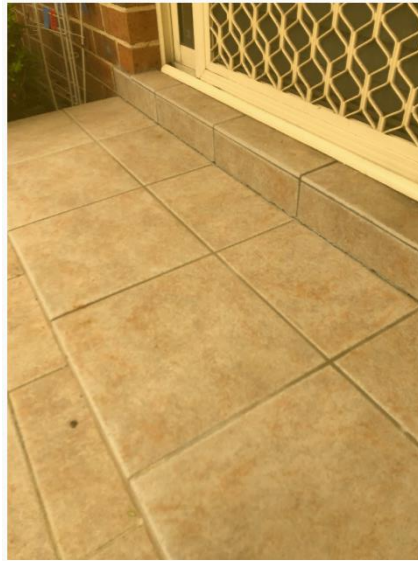
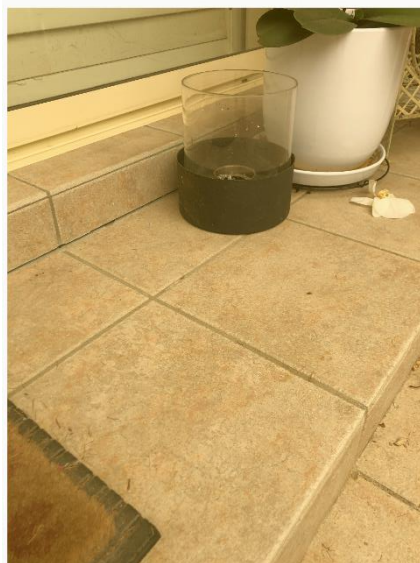
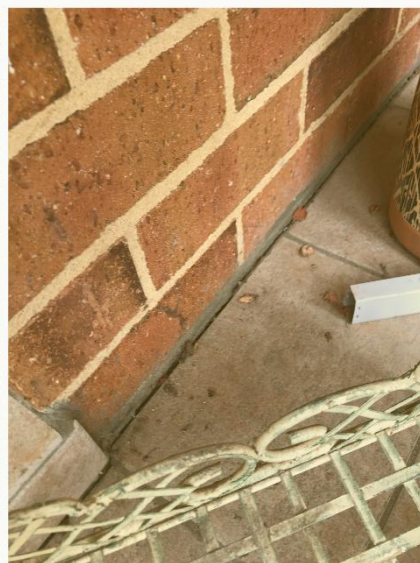
13. Eastern elevation side courtyard concrete step up and sliding door threshold has a crack between the floor tiles and skirting tiles, this is a possible concealed entry point within the settlement of the concrete slab and external wall junction.

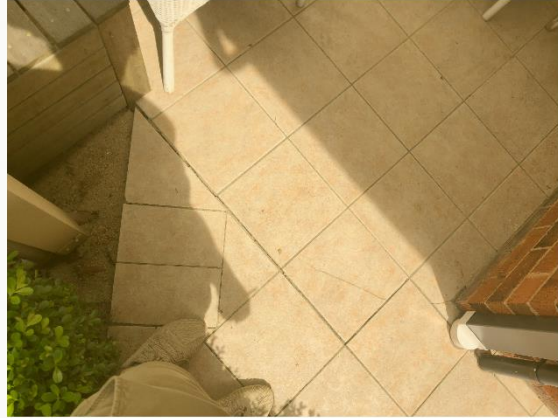
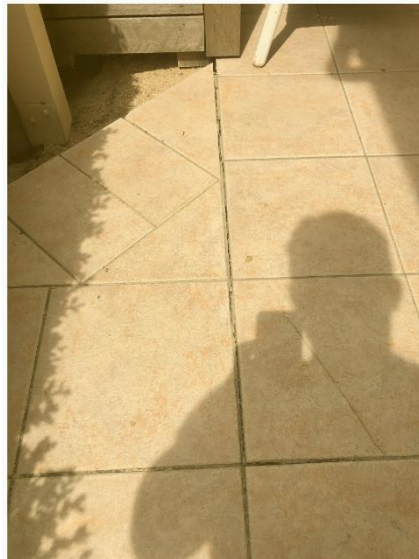
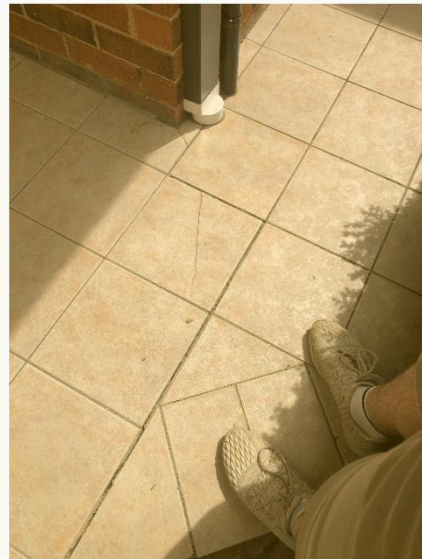
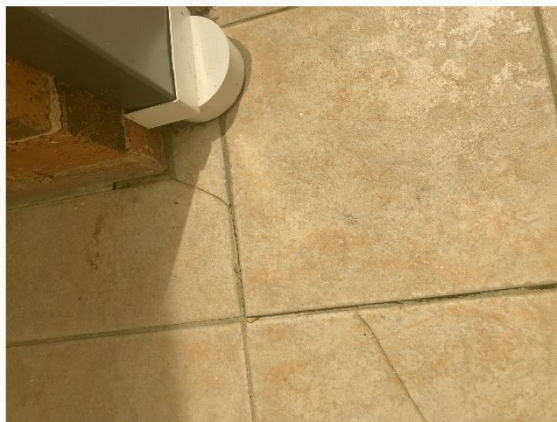
14. Outside elevation covered patio has a concrete slab / pathway leading to the garage, there is an approx. 1 L/M crack within the floor tiles. I assume this is due to old and new concrete being poured not in the one pour, and the crack could be a concealed entry point into the South East corner adjacent to downpipe.

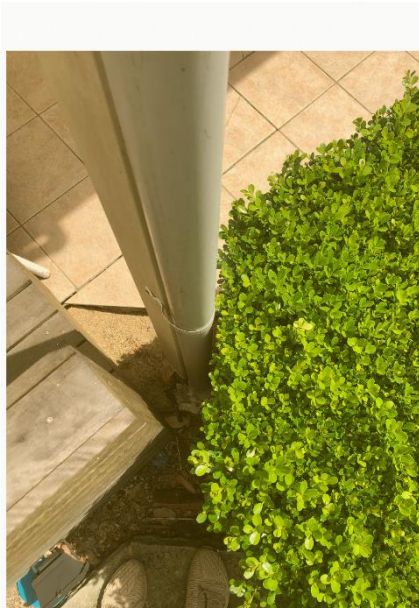
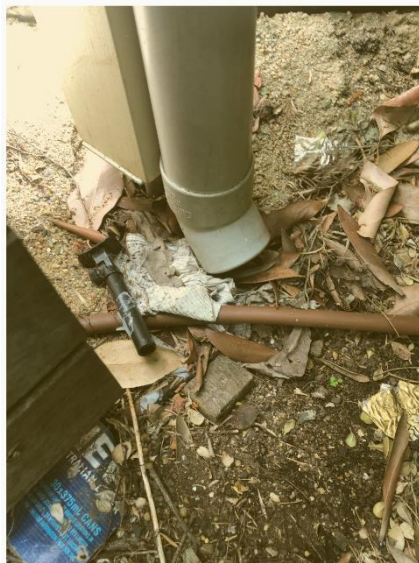
15. Within the Eastern elevation courtyard which has a PVC roof lining, that is drain into a gutter and down a 75 mm PVC downpipe, this PVC downpipe drains directly onto the floor and not in a stormwater line nor pit. Not ideal for pest infestation

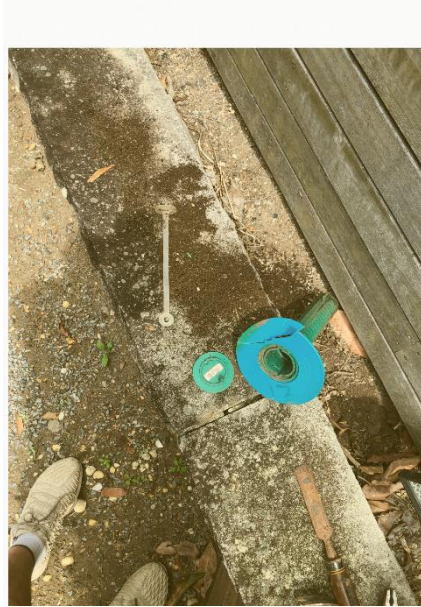
16. Within 1 m of the downpipe, there was termite bait station number 17 located beneath the built-in joinery, it was examined to find a mixture of soil and termite mud tunnelling within the bait station.

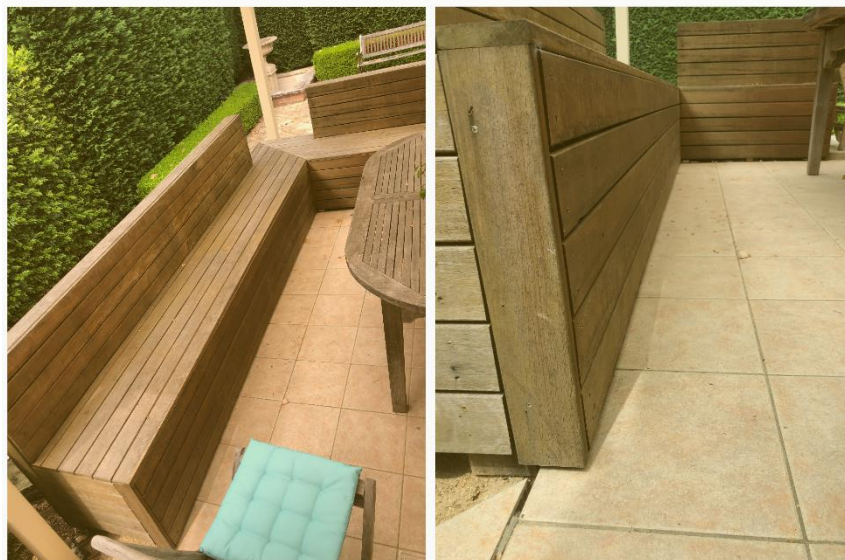
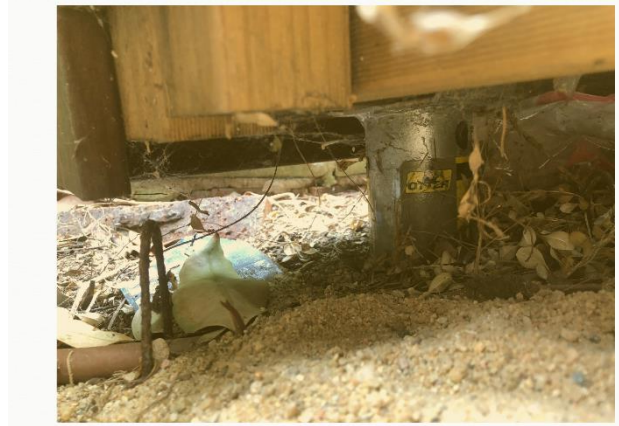
17. The built-in seating beneath the Eastern courtyard is made out of a suspended steel post pier and treated pine timber framing substrate, with cladding that would appear to be a hardwood material with no termite prevention barriers installed, along the perimeter of the seating no termites nor mud tunnel seen, but elevating or cutting back of the bottom course vertical cladding would be recommended to encourage ventilation and daylight to reduce the possibility for subterranean termite infestation which would only result in the timber cladding of the seat being compromised.

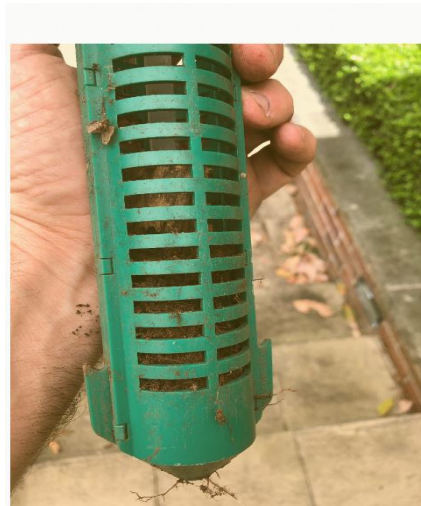
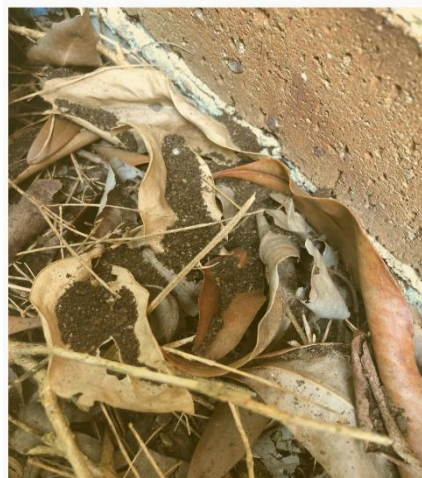
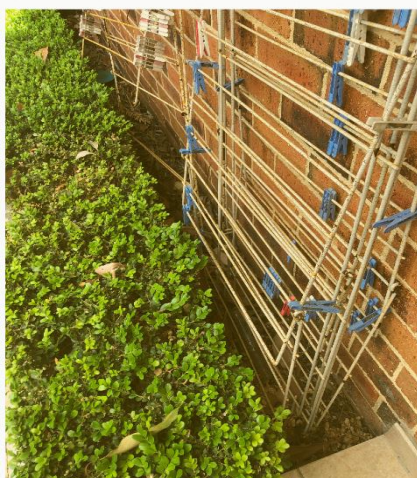
18. The Eastern elevation beneath the bedroom window, there is a garden mulch and open porous garden beds hard up against the external wall of the home. There is a termite bait station located approximately 2.4 m due south of the living room door, the timber bait within the canister was eaten by approx. 80% by past termite activity, no live termites nor damp soil nor mud seen within this canister.

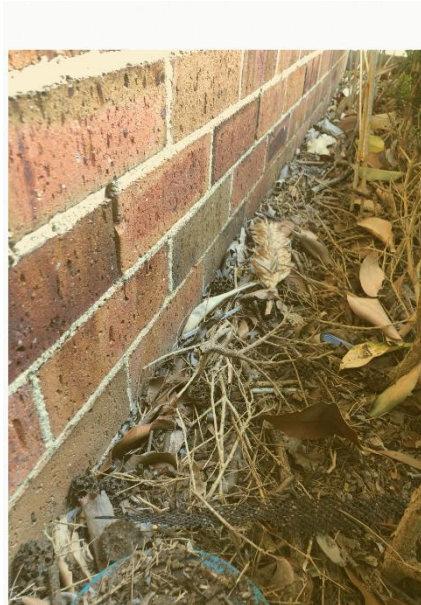
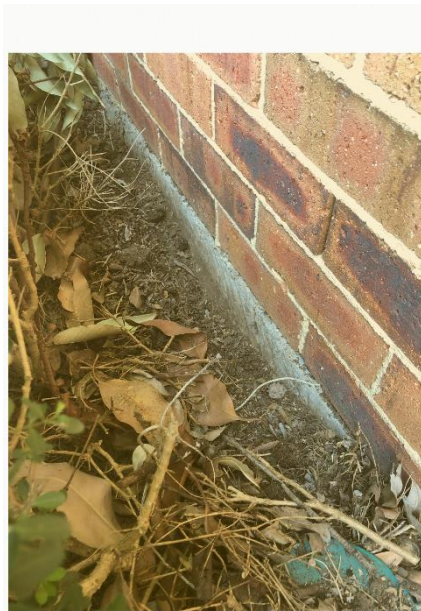
19. Timber pergola was checked and no past nor present damage nor pest activity found.
20. Along the Southern and Eastern elevations rear left corner external walls enclosing the rear bedroom, both have elevated garden beds above the concrete slab and first course brick joint, allowing for a concealed entry point for termites into the cavity of this property.

Within the second image it is seen what a typical garden bed should look like as I have lowered the garden bed by approx. 100 mm exposing the top of the concrete slab and the first course brickwork lowering the risk for termite entry points into the property.

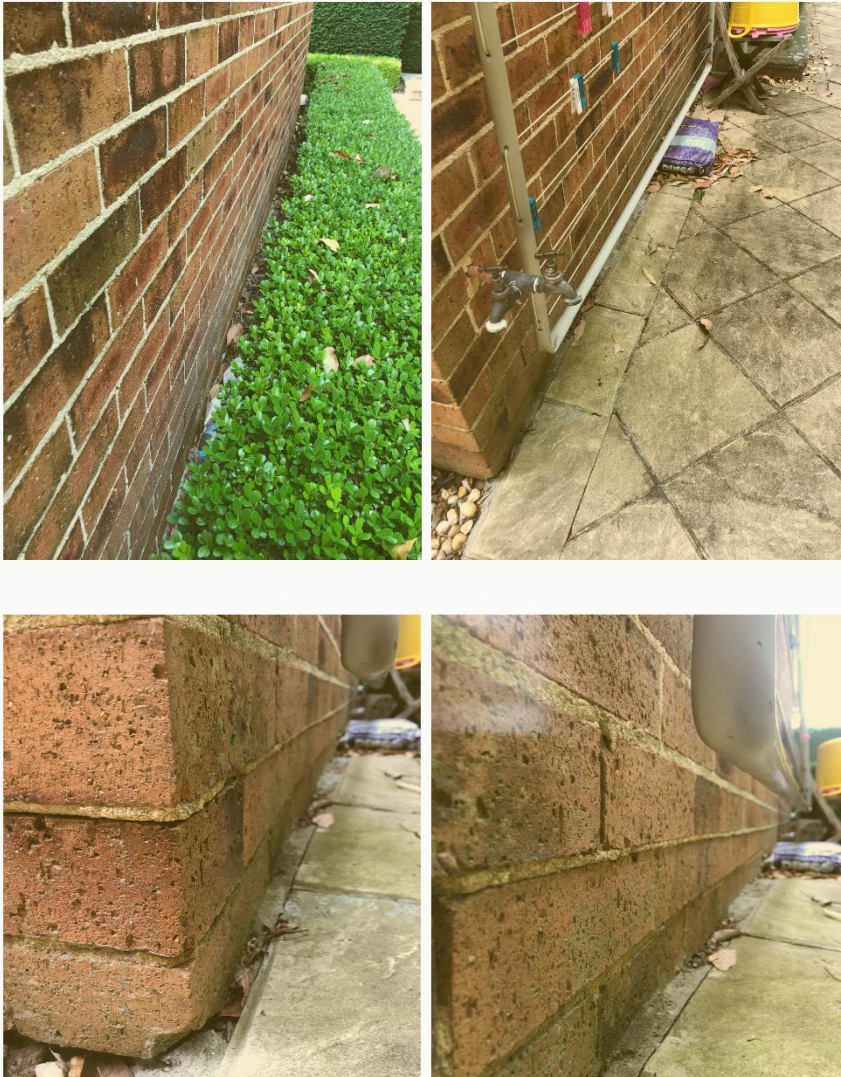
22. Over the Southern elevation of the home where the garden bed is also concealing the concrete slab and brick course junction allowing a concealed entry point for termites into the cavity.
23. Within the rear elevation/Southern wall Due West, the pavers beneath the clothesline should be lowered to expose or express the concrete floor of the house and first course of brickwork to eliminate any concealed entry points into the cavity walls of the home.

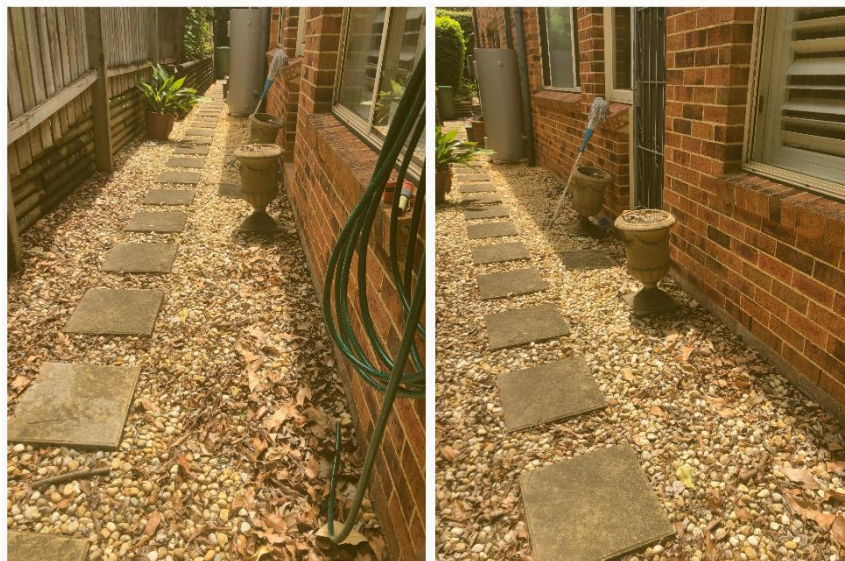
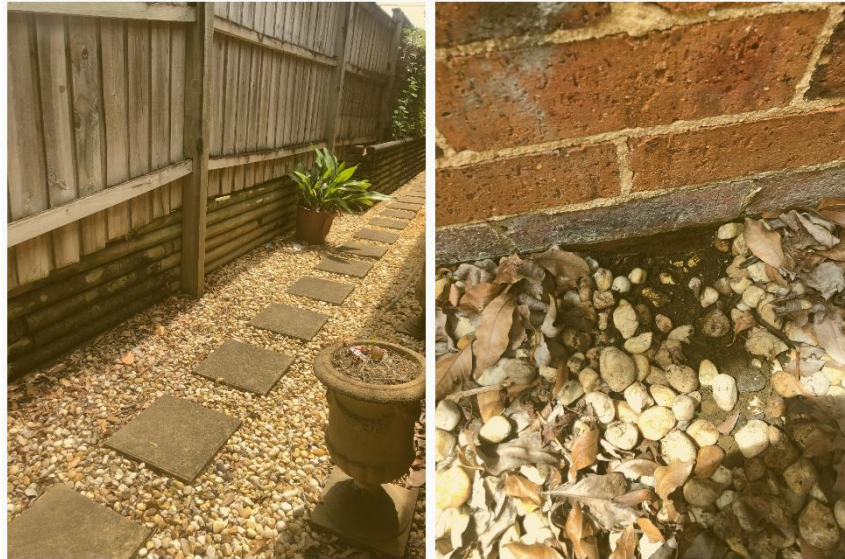
26. The Western elevation of the property has an open porous pathway lined with pebbles and soil substrate.
27. The gradient of the land has a slight fall towards the property, resulting in the moisture from the right side neighbour being directed towards this property which encourages dampness and moisture along the entire Western elevation of the home.
28. With the pebbles being installed along the entire Western elevation to a height which conceals the house slab on ground and first course brickwork, this allows for a concealed entry point for termites into the property.
29. Lowering of the path and pebble lined pathway is recommended to expose the house slab on ground and first brick course junction.

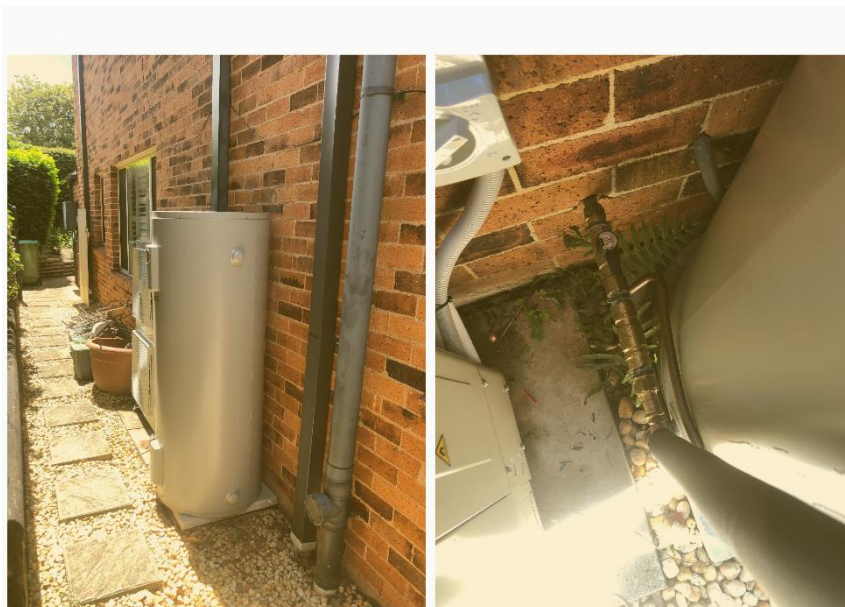
30. Along the Western elevation there are two items that generate moisture; a hot water system which has its overflow and relief valve draining directly onto the floor, together with the air conditioning compressor condensation overflow pipe draining directly onto the floor, this will create dampness within the local area which will attract termites and elevate the risk of pest infestation and entry into the property.
31. All discharges of moisture should be directed and plumbed into the adjacent down pipe located between the hot water system and sewer stack.

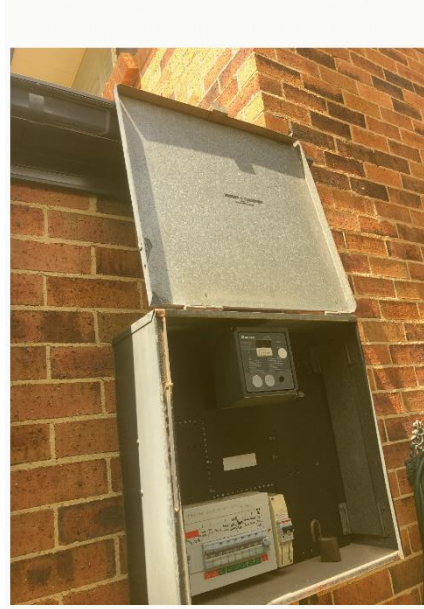
32. Along the Western elevation, there is an electrical meter box, within the electrical meter box there is no sticker confirming previous pest inspections nor treatment plans nor barriers installed to the original build or ongoing for maintenance.

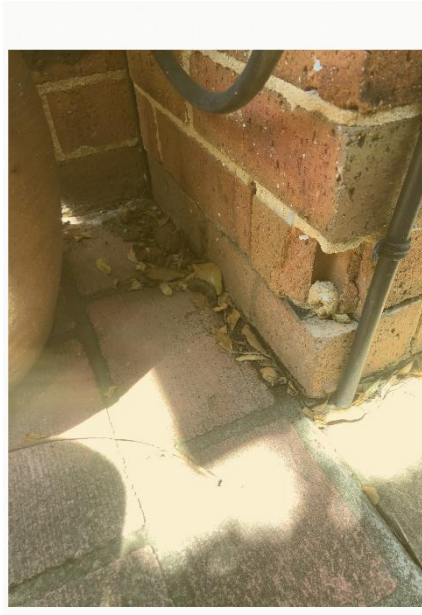
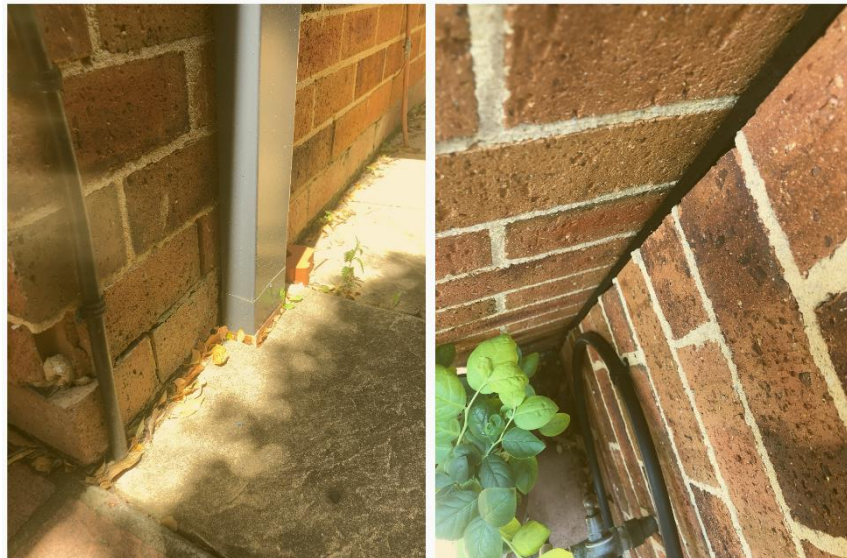
33. In the front right corner of the house, there is differential movement within the external corner of the building, this shows a possible failure within the damp proof course and termite barrier installation within the cavity of this building.
34. Within 500 mm from this location, there is a vertical control joint within the external face brickwork - this is a prime location for termite entry into the property beyond the dampproof course installation and beyond a concealed termite barrier mesh or treatment applied to the wall cavity.

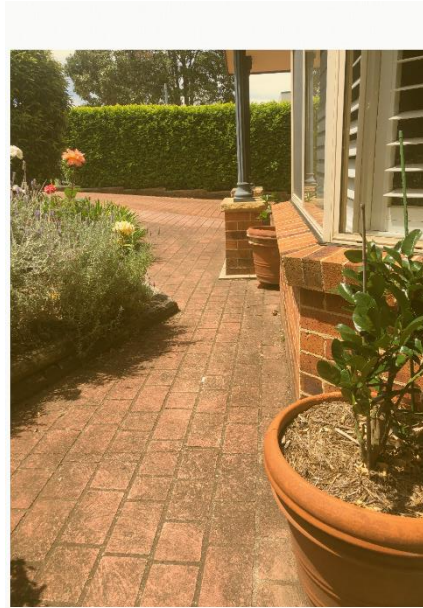
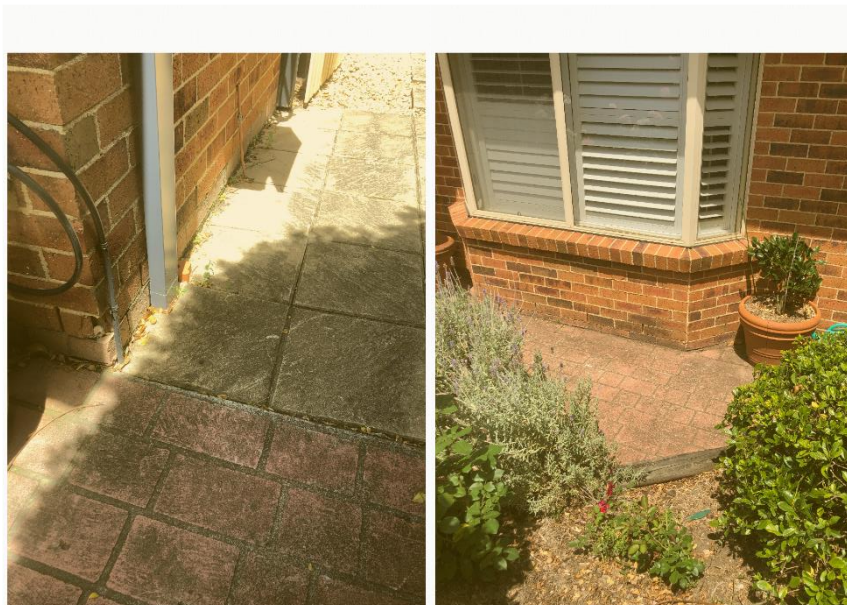
35. Within the street elevation of the home Due North, there is a concrete slab on ground hard up against the external walls of the property, the concrete driveway and slab on ground pathways all encourages water to strike up and pool against the external walls of the home.

With the concrete slab of the house and first course of brickwork being concealed by the concrete slab, there is a concealed entry point for termites into the cavities of the building, together with possible failures within the damp proof course and termite barrier system installed within the cavities, making this home prone for termite infestation beneath the concrete slab within the street elevation and right side paved area.

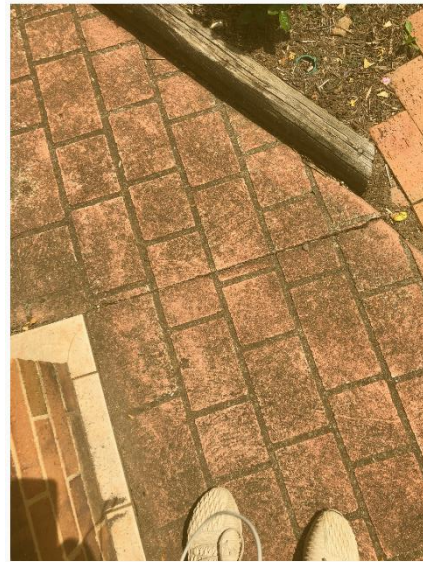
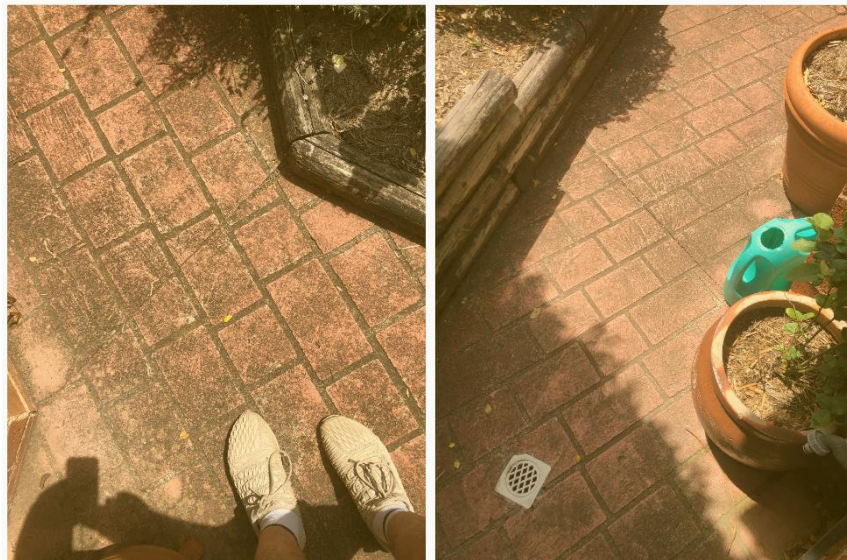
36. Along the street elevation/Northern elevation of the home, the concrete pathway is cracked in various locations - termites can travel through the concrete cracks to reach the cavity walls within the street elevation of the home, making their entry point concealed and undetected.

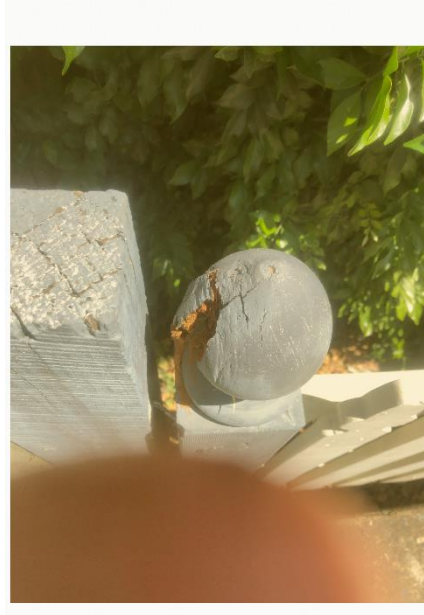
38. The street boundary fence Due East has wood rot in the timber post trimming piece.

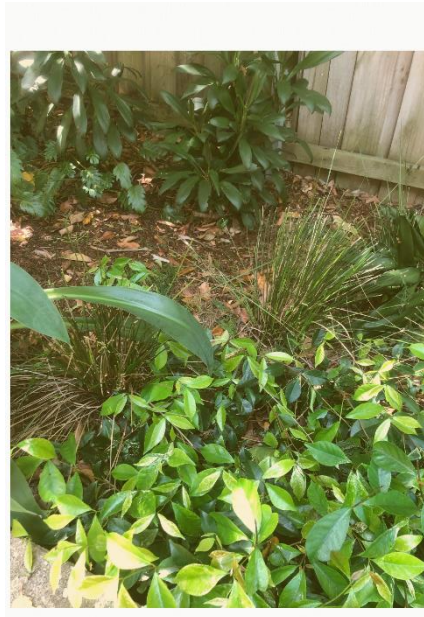
39. Within the right side, Due West, the boundary fence is made out of treated pine - no traces of mud tunnels or termite damage to the timber fence nor timber retaining wall.
40. I inspected the Southern elevation / rear boundary fence, there was no evidence of any termite activity or wood rot or mud tunnelling within the fence or within the property, I walked through the rear neighbour's property, and I found the entire garden bed lined with a timber mulch, not ideal and t me mindful of this in the future when treatments are being applied to the property

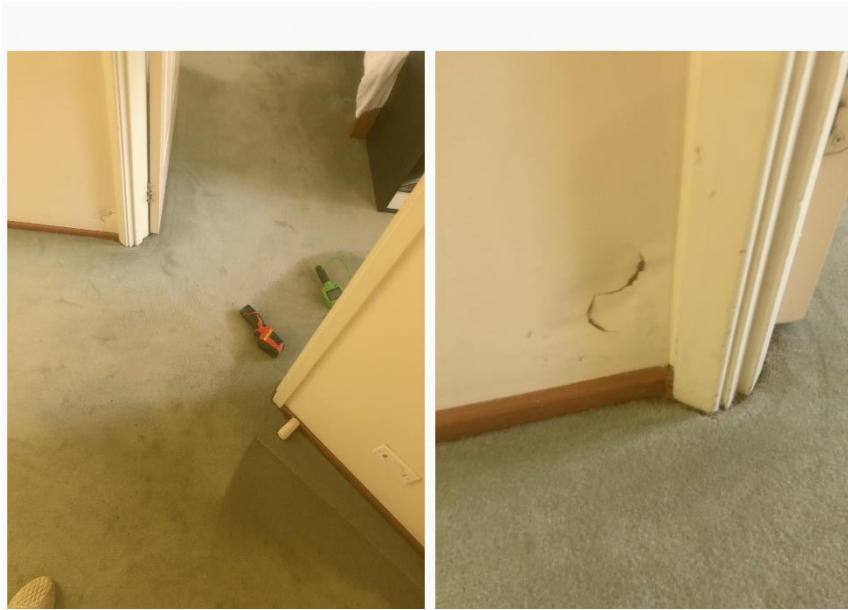
42. Entry wall and ground floor bathroom doorjamb, termite activity within the left and right side doorjambs/door styles.

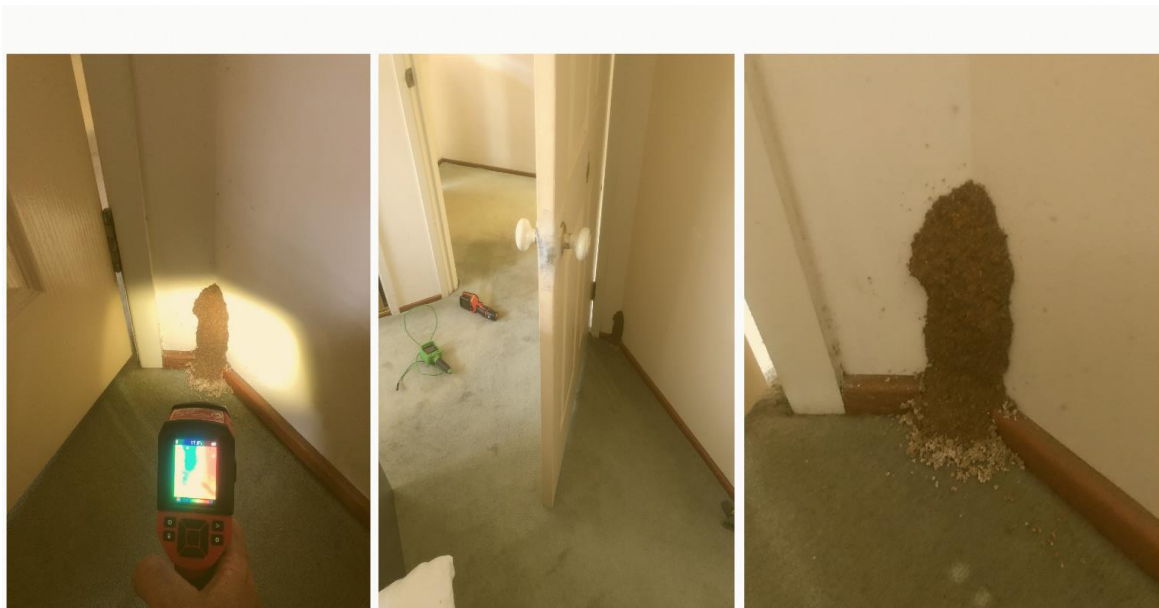
43. Within the ground floor bedroom, behind the door, there is a termite mound within the internal junction of the plasterboard wall and timber skirting boards.

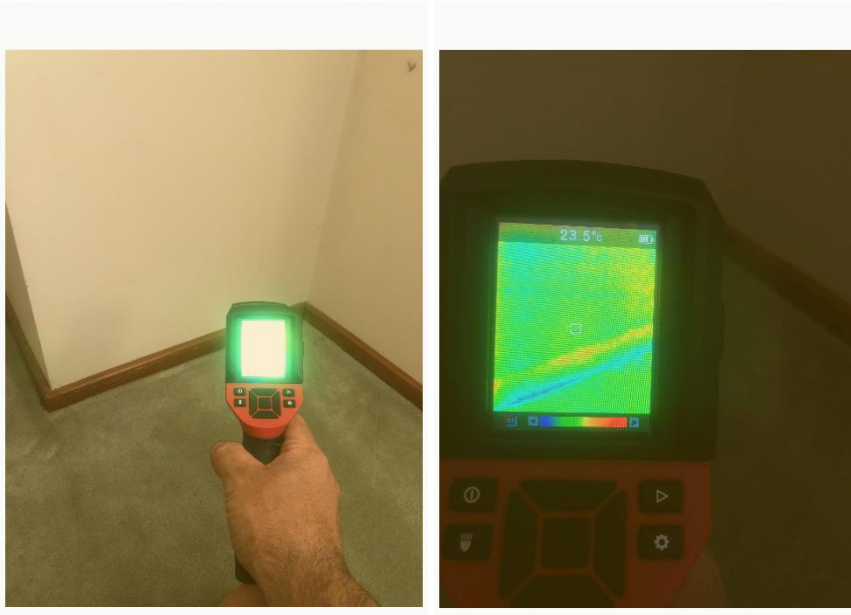
44. Ground floor front bedroom in the North East corner, there are heat readings within the timber skirting boards.

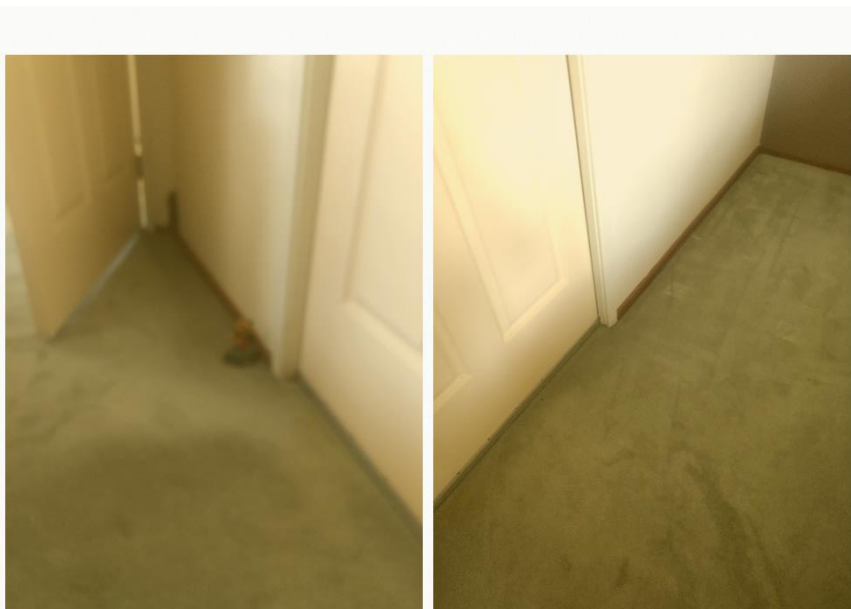
45. Within the ground floor front bedroom, behind the bed wall there was minor traces of heat and energy within the timber skirting boards.
46. Within the wall dividing the bathroom and ensuite, there was a thermal reading within the timber skirting boards and wall frames within 300 mm off the floor running the full length of the wall.

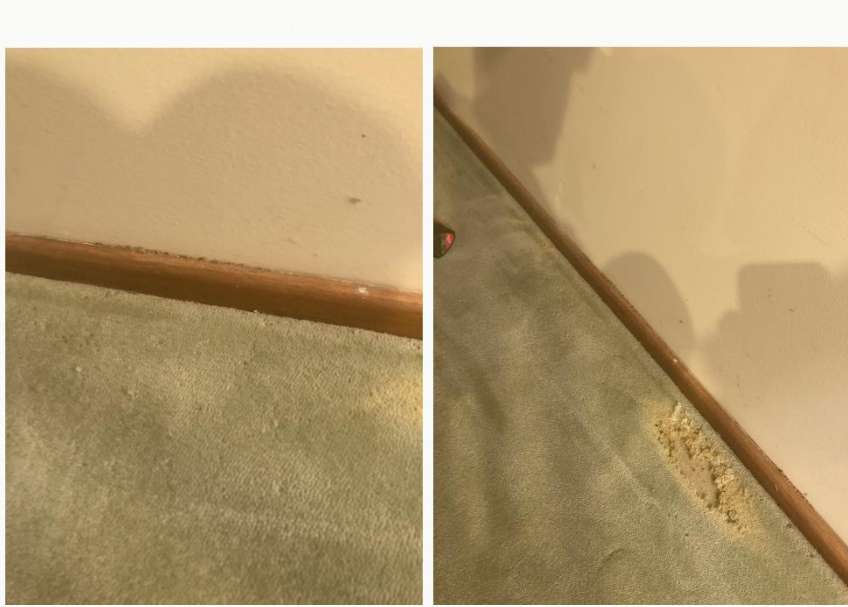
47. Beneath the staircase, there is a two-step landing - in the raised landing area and adjacent to the worn carpet area there is termite tunnelling and mud trails found on top of the timber skirting board.

Minor readings picked up within the thermal camera above the timber skirting boards and the left and right side of the mud tunnelling.

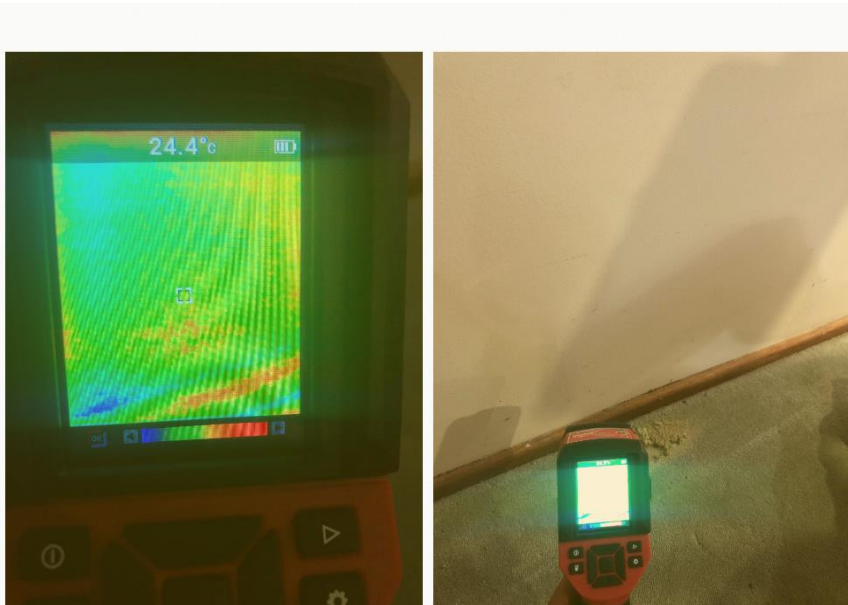
48. In the image above there is a second mud tunnel seen on top of the timber skirting board below the staircase.

Minor heat reading picked up within my thermal camera assessment

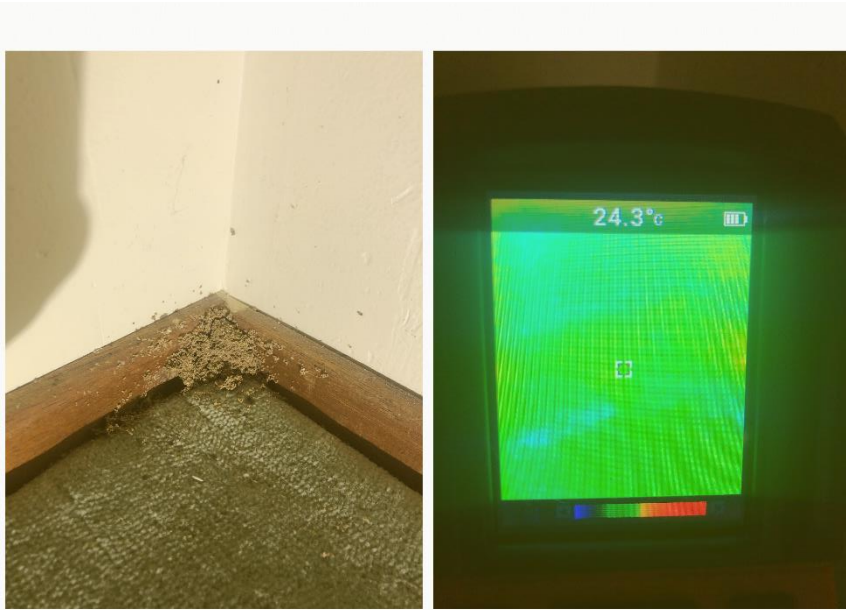
49. Termite mound found in the internal junction of the timber skirting boards below the stairwell/landing.

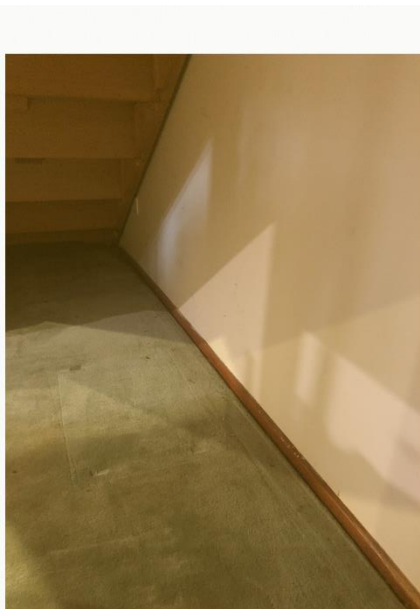
50. No heat found within the timber skirting boards and wall frames in this area.
51. Timber skirting board running below the stairwell has minor traces of heat within the wall frame and timber skirting boards.

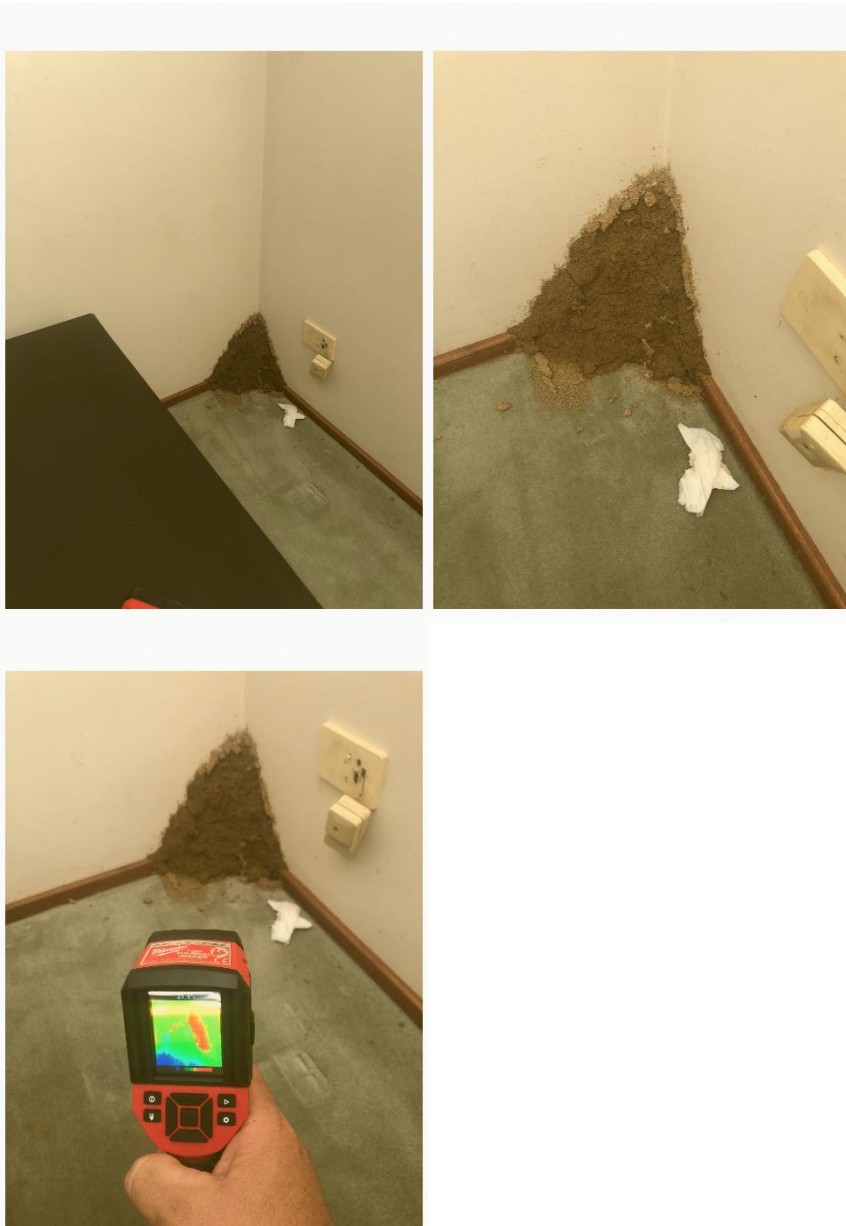
52. Within the ground floor, in the back right bedroom internal corner within the South West corner of the bedroom, there is a large termite mound of soil currently located in the timber skirting board and plasterboard wall linings - there were live termites picked up within my thermal camera assessment.

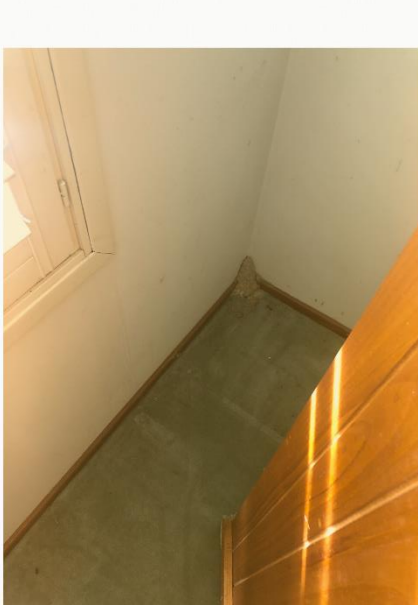
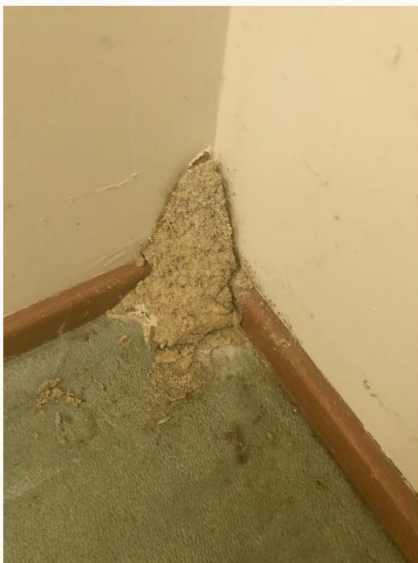
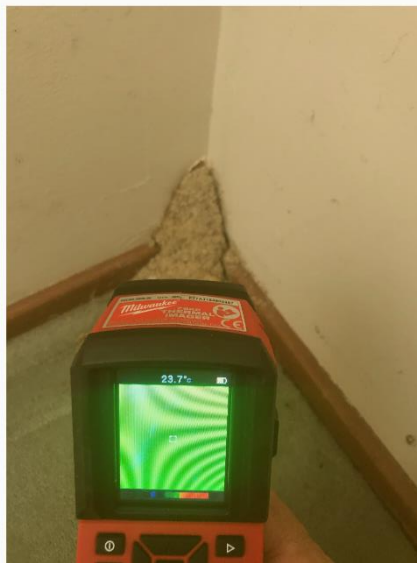
53. A second location was found in the rear bedroom behind the chest of drawers, located to the right side of the window facing West, below are the images taken on the day of my inspection.

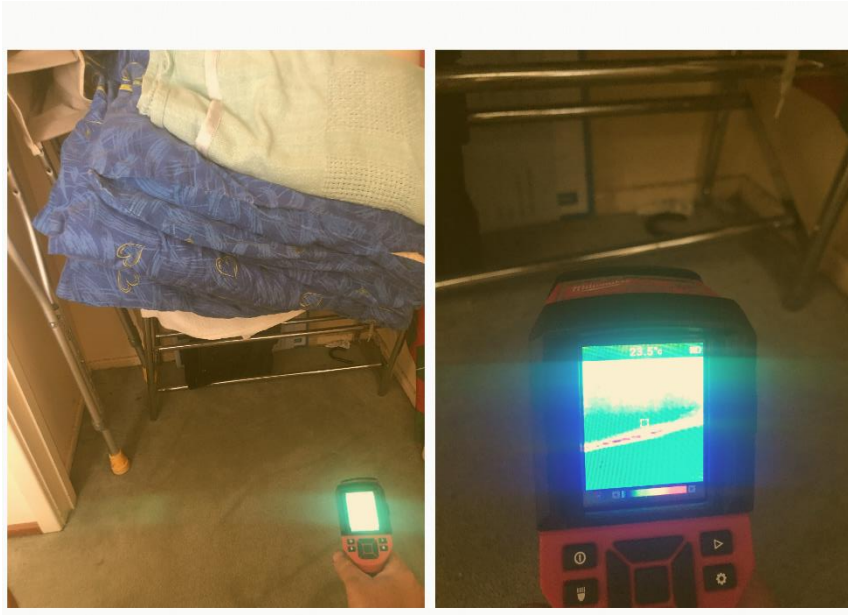
55. Within the rear right ground floor bedroom within the robe, there was a thermal mass reading picked up within the timber skirting board running the width of the robe.
