## TERMITE - SITE ASSESSMENT & ADVICE

**Site Address:** 32 Princes Street Hunters Hill NSW 2110

**Report Type:** Pest Inspection Report

**Date of Inspection (s):** 25/10/2021 & 28/10/2021

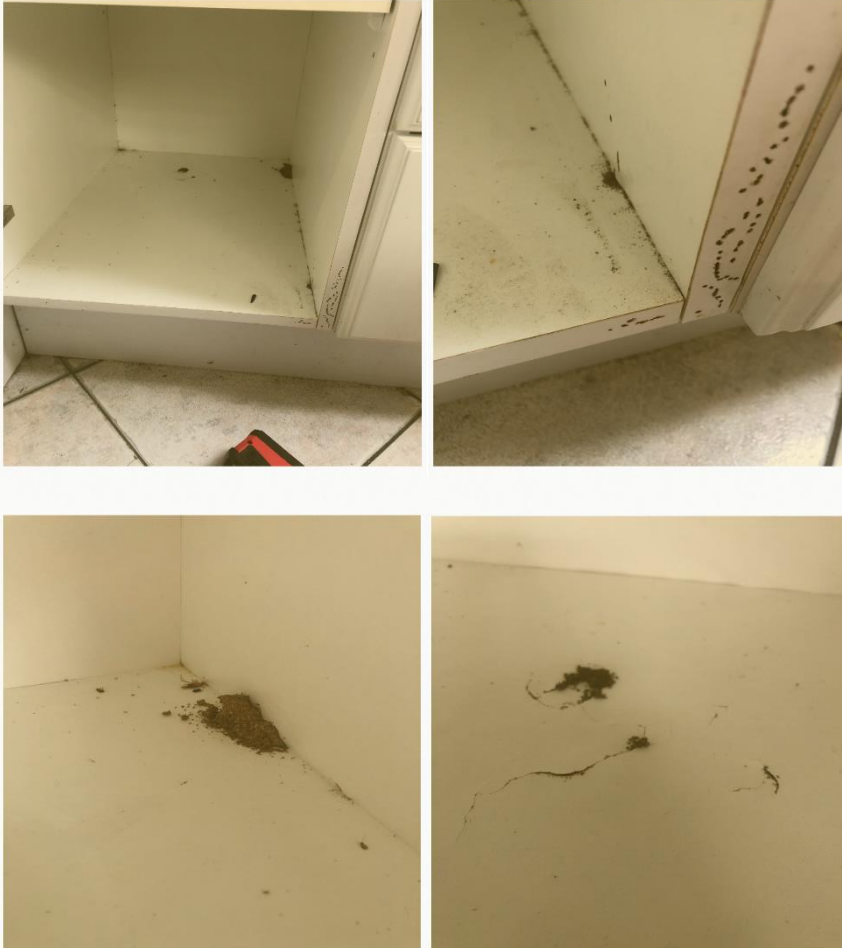
56. Within the kitchen cupboard, located to the left of the pot drawers, there is soil / mud mount located through four locations within the cupboard, back left corner, in the middle towards the rear of the bottom shelf, back right corner approximately 100 mm from the internal corner, and on the right side of the wall there is a small mount approximately 50 mm back from the face of the carcass.

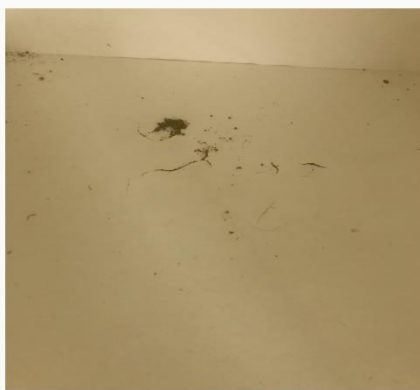
57. Within the carcass located to the right side of the fridge and left side of the pot drawers, the bottom shelf of the carcass has been completely eaten out by termites. When using my thermal camera there was no heat readings found within the equipment resulting in no active termites in this location.

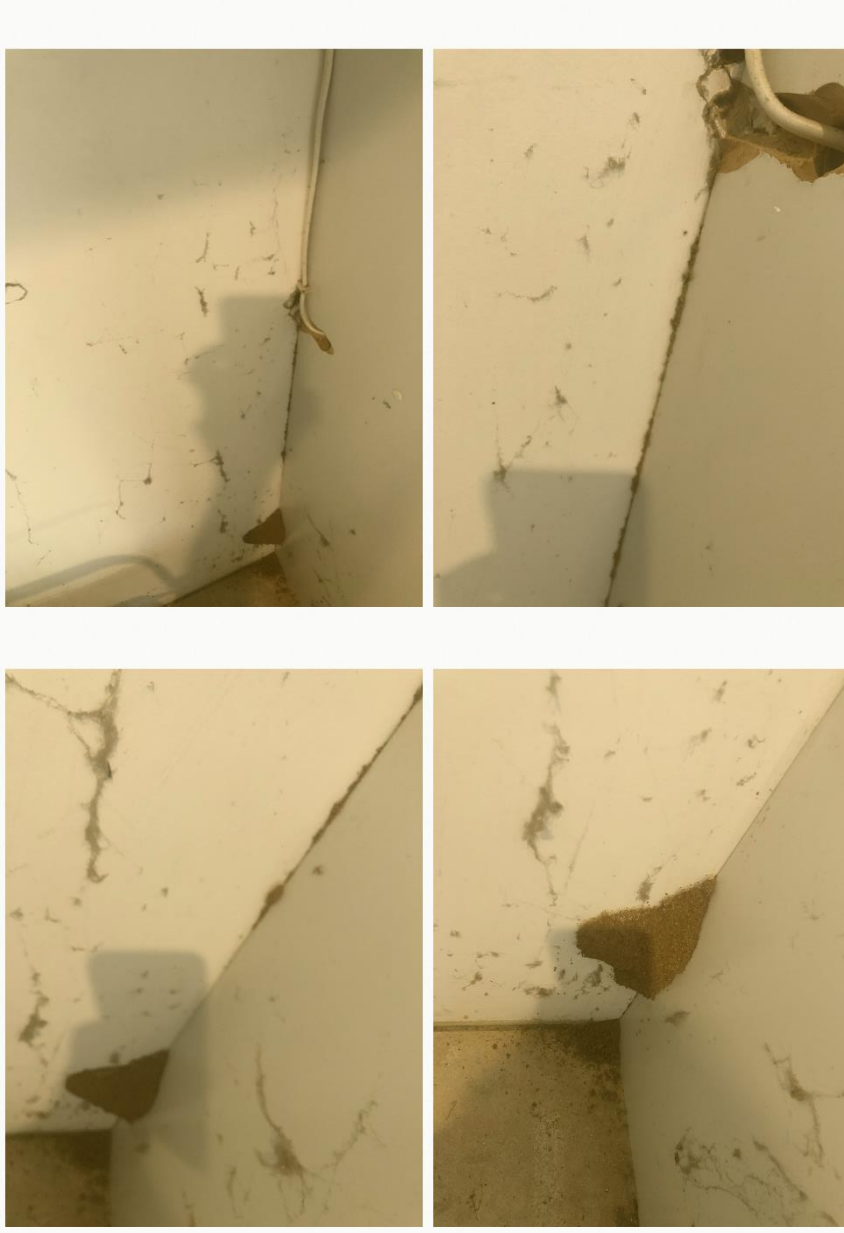
58. Within the fridge alcove within the right end panel approx. 200 mm, there was a mud mount fixed to the rear plasterboard wall and the polyurethane end panel, together with a small amount on the floor tiles, joinery and plasterboard wall lining and a third location approximately 500 mm from the ground up until the electrical cable, where it returns into the benchtop height.

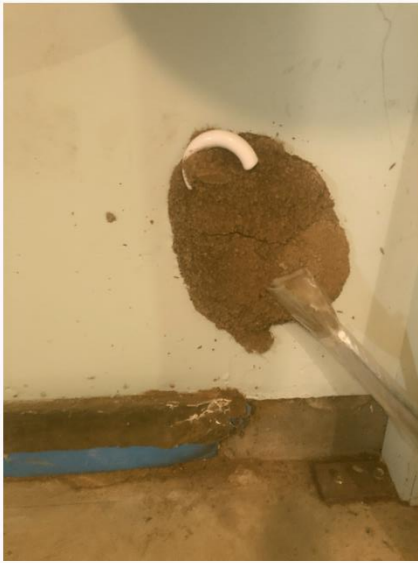
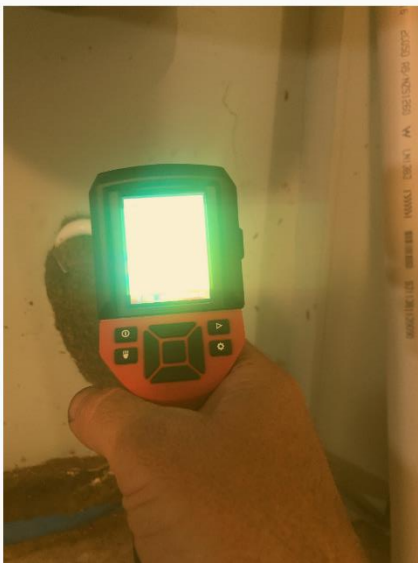
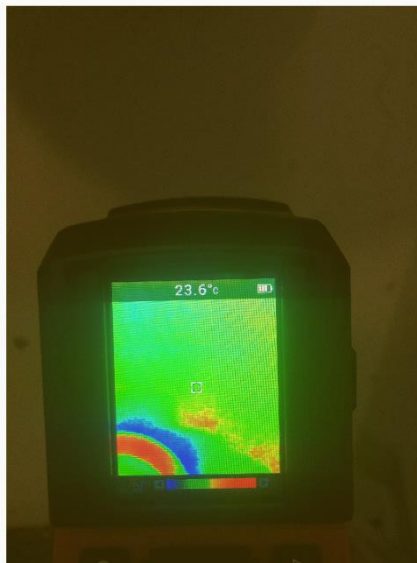
59. Within the garage, below the vacuum system, there is a large mud mount within the wall approx. between 100 mm to 600 mm from the timber wall frame where it sits on the floor.

There was thermal mass and heat found when using the thermal camera around the perimeter and through the body of the mud patch.

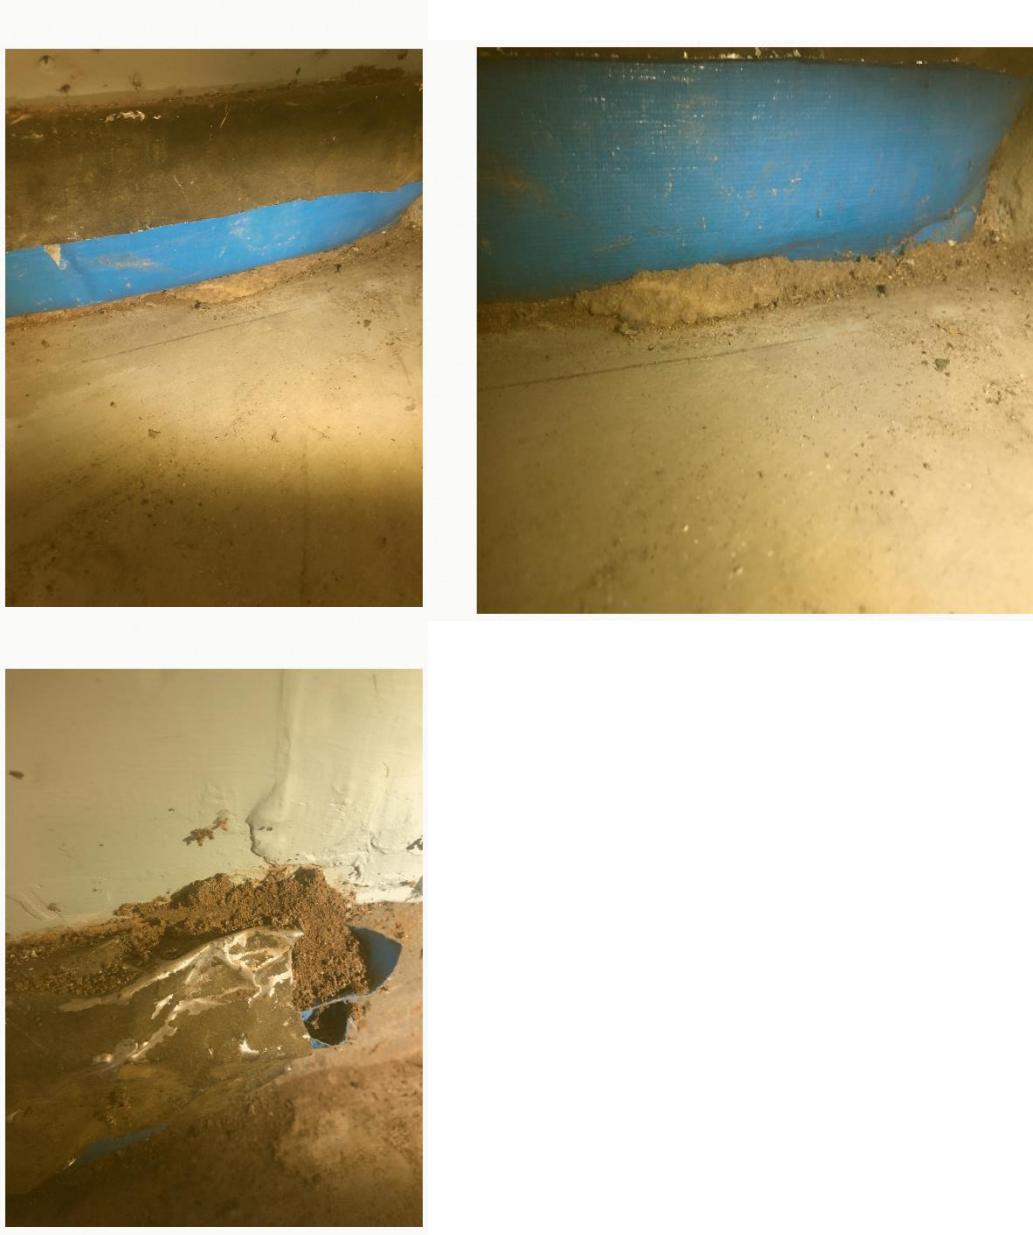
60. There appears to be considerable mud tunnelling seen between the house slab and the garage infill slab located beneath the centralised vacuuming system within the garage.

No thermal readings found within my thermal camera on the day of my inspection.

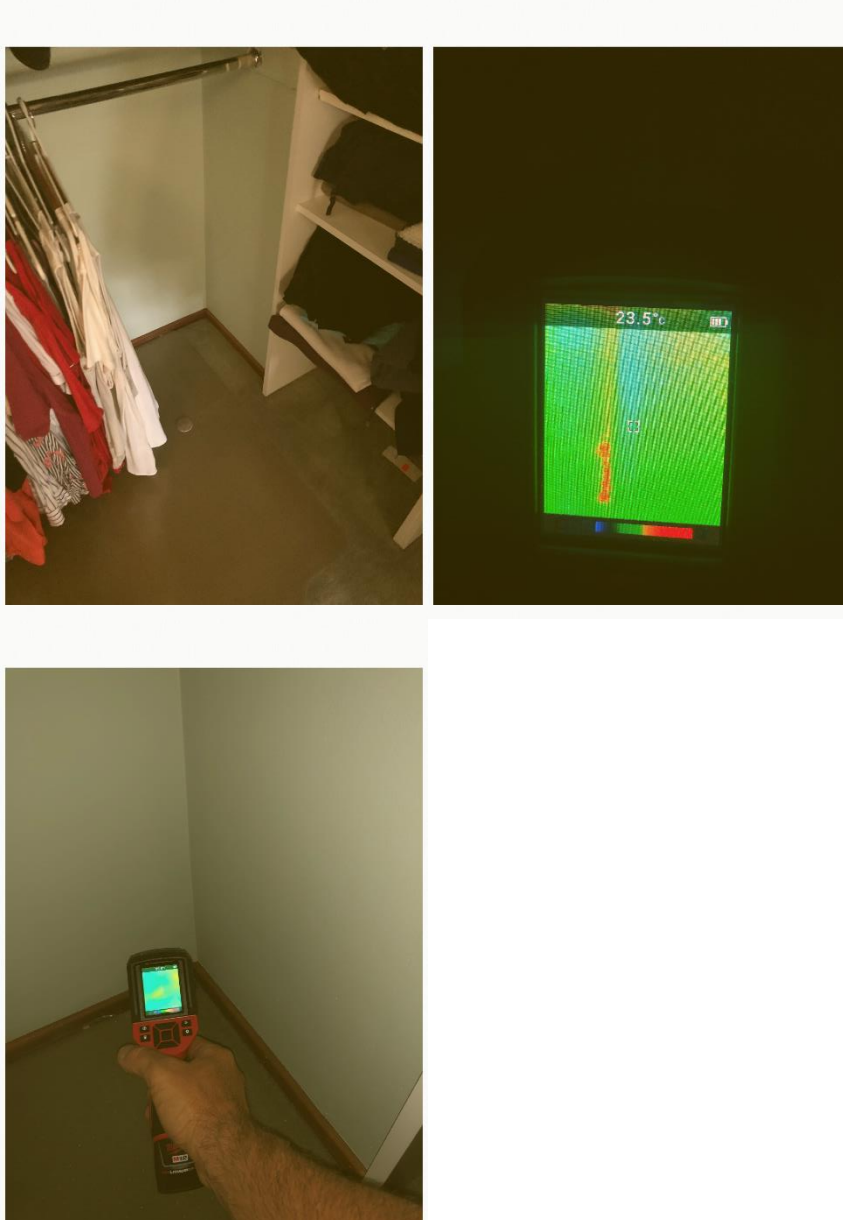
61. First floor master bedroom walk-in robe, back right corner within the internal junction of the vertical bulkhead, it has a reading within the internal junction plasterboard area, of an excess of 31° yesterday and again today on my second site inspection - further investigation is required as the reading in this aspect is inconsistent with termite infestation and possible electrical cabling or service lines may be found beneath the plasterboard wall linings.

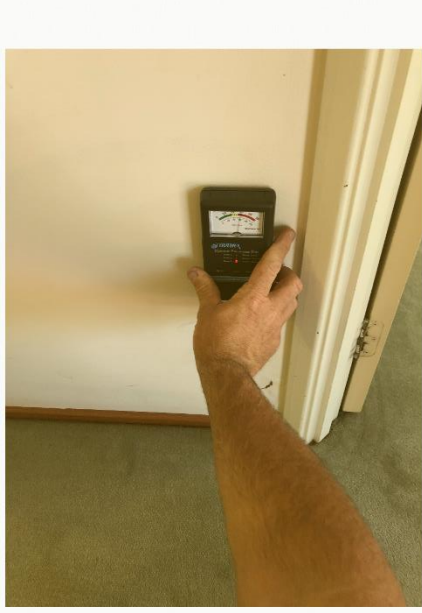
62. Ground floor entry hallway wall dividing the hallway and ensuite has excessive moisture readings within the plasterboard within 500 mm from the left style doorjamb and as high as 500 mm from the floor.
