# INDEPENDENT EXPERT BUILDING DEFECTS REPORT

## 283–289 Blaxland Road, Ryde NSW

**Strata Plan:** SP 92028

**Purpose:** Assessment of alleged defective and incomplete building work

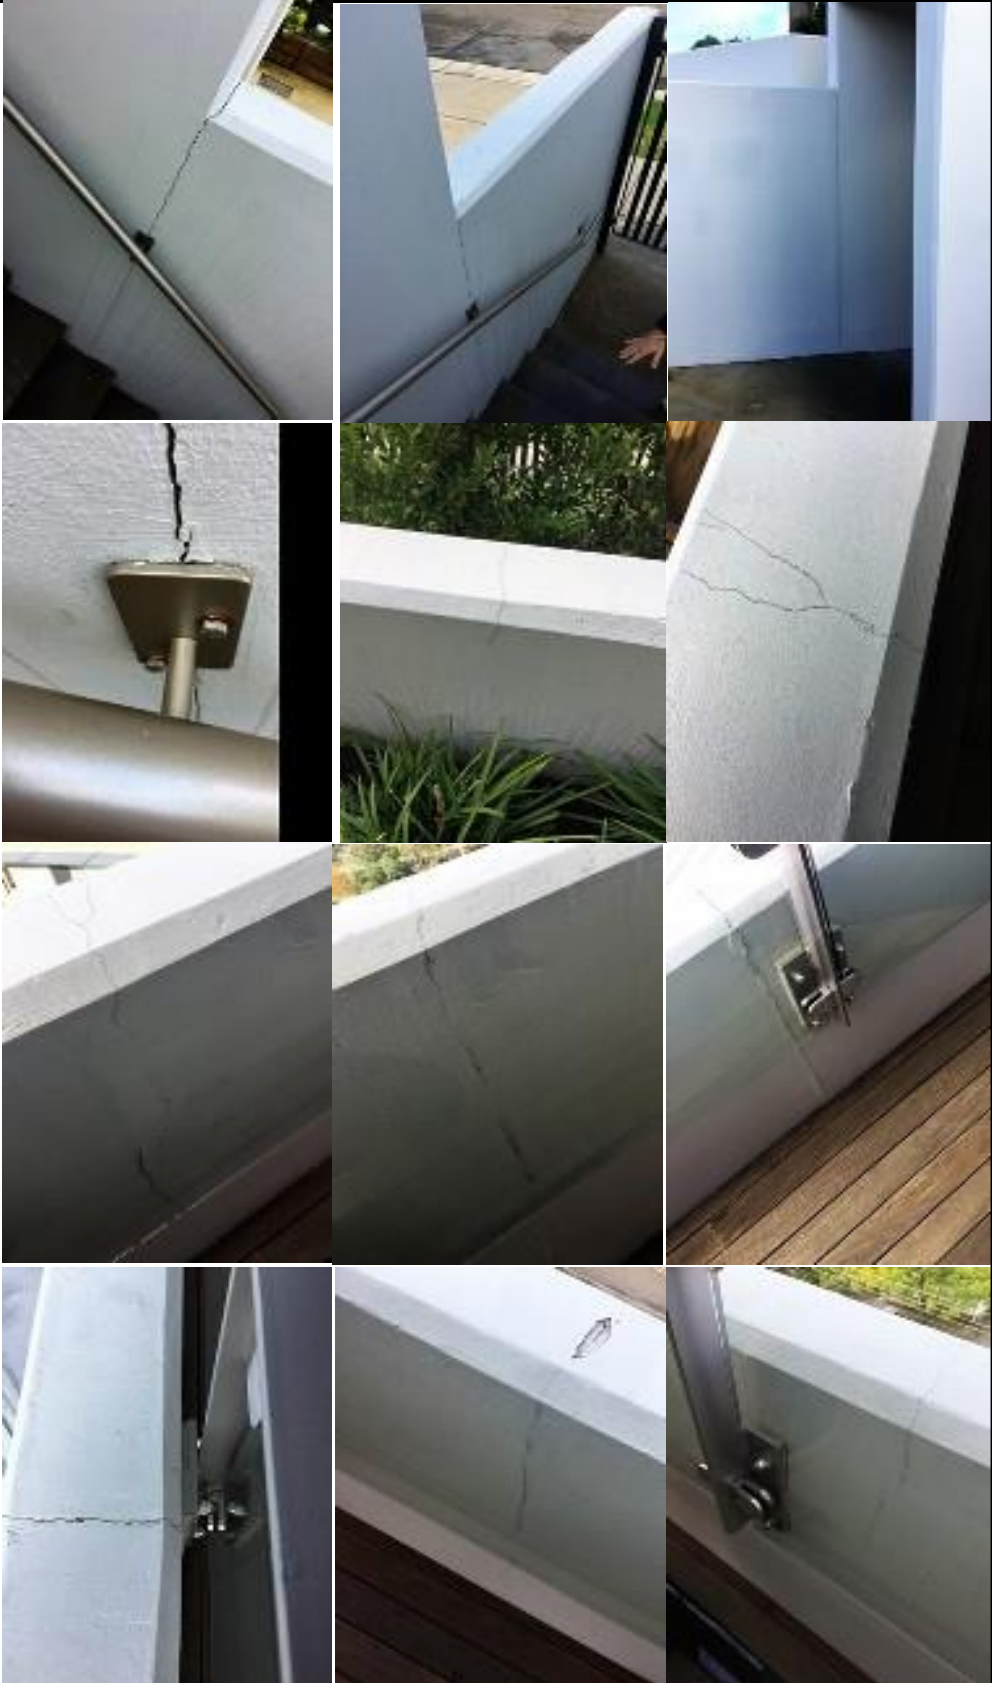
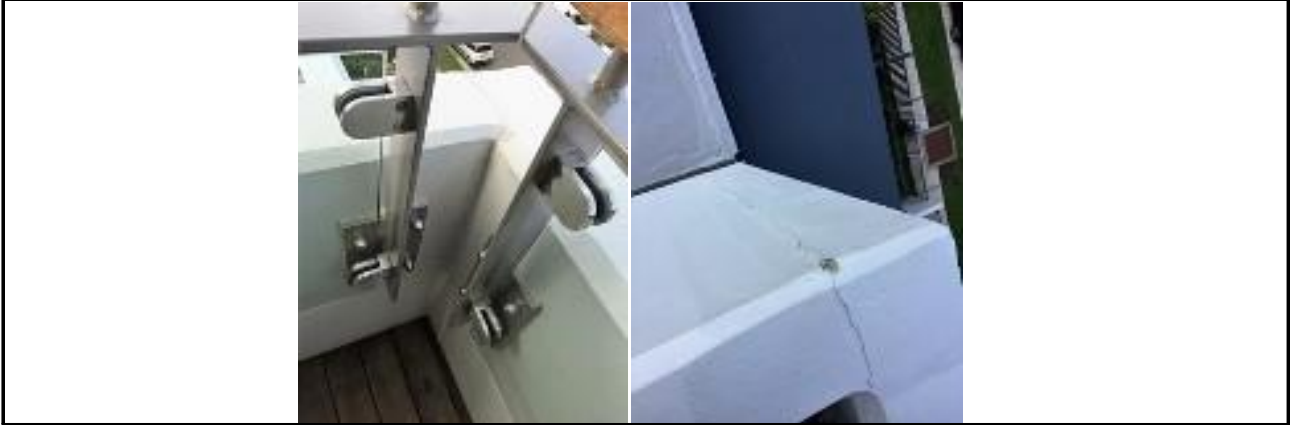
Cracking was observed within concrete upturns/walls.

Where appropriate, a structural engineer should review the cracking before permanent repair.

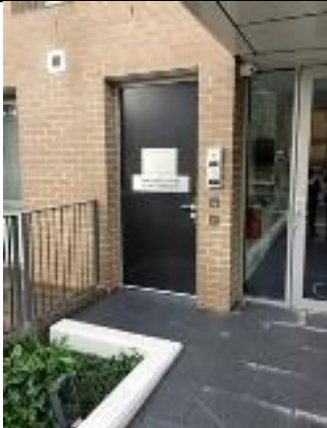
A fire door adjacent to the main entrance facing Blaxland Road was weather damaged and identified as requiring replacement.

Any replacement should preserve the required fire-rating and certification of the complete doorset.

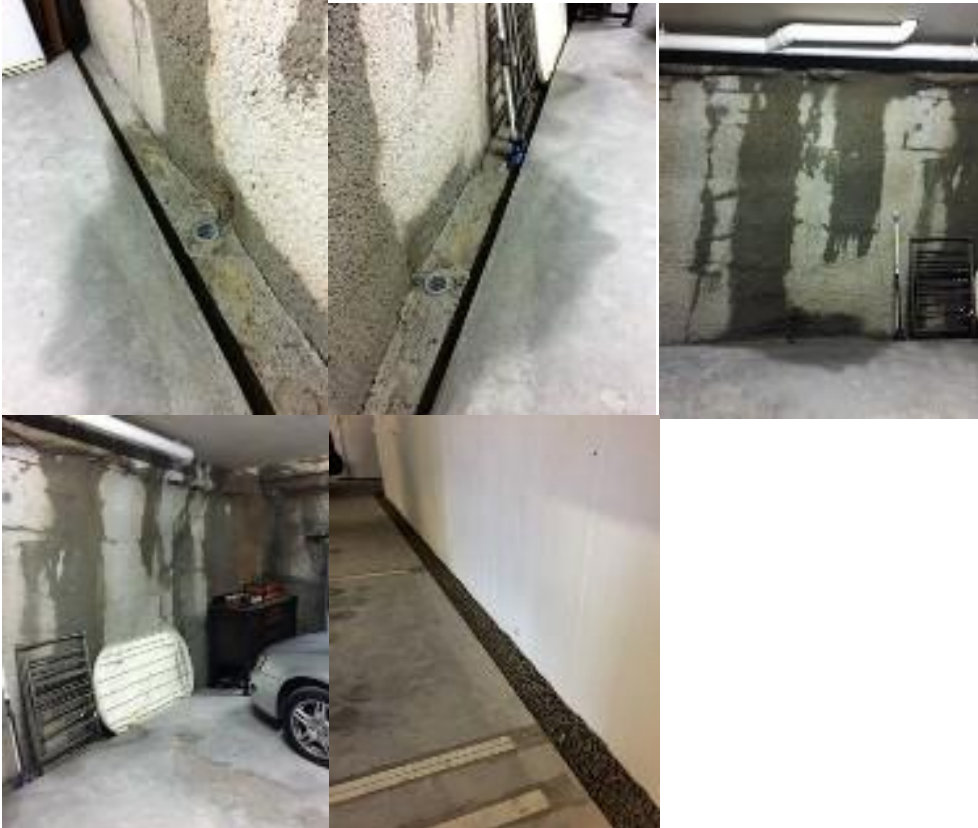
Moisture was observed entering through garage walls and was not being adequately captured by the spoon-drain arrangement.

Before rectification, the source and route of moisture should be established.

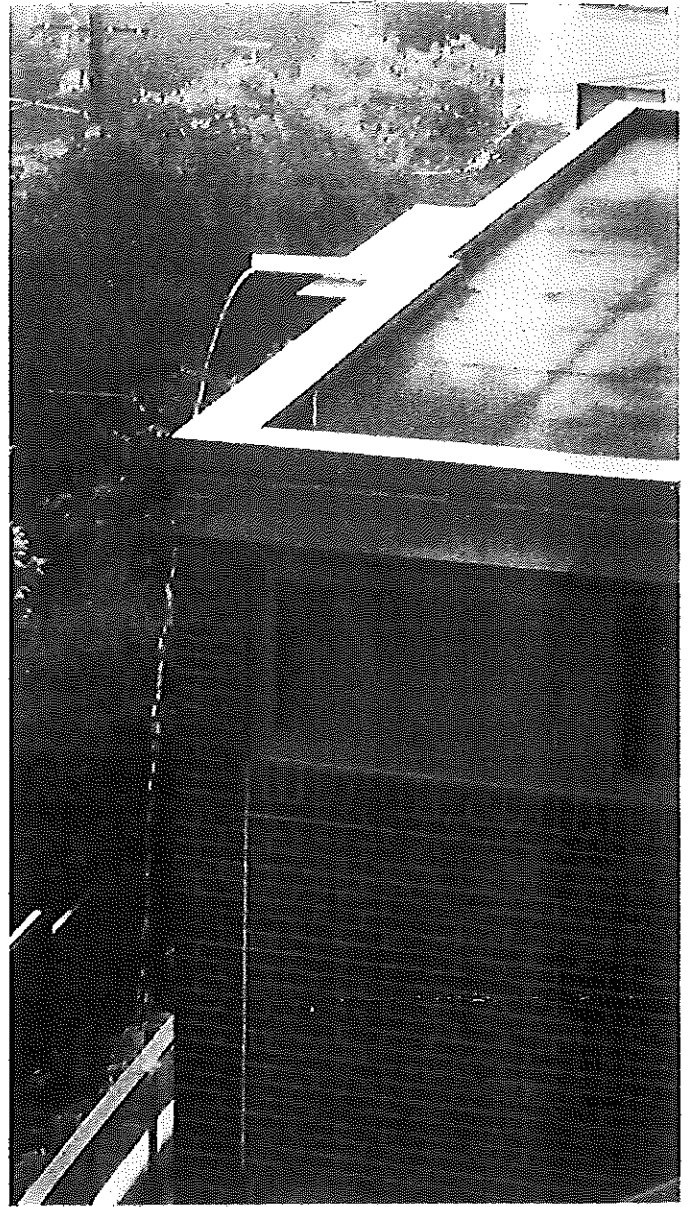
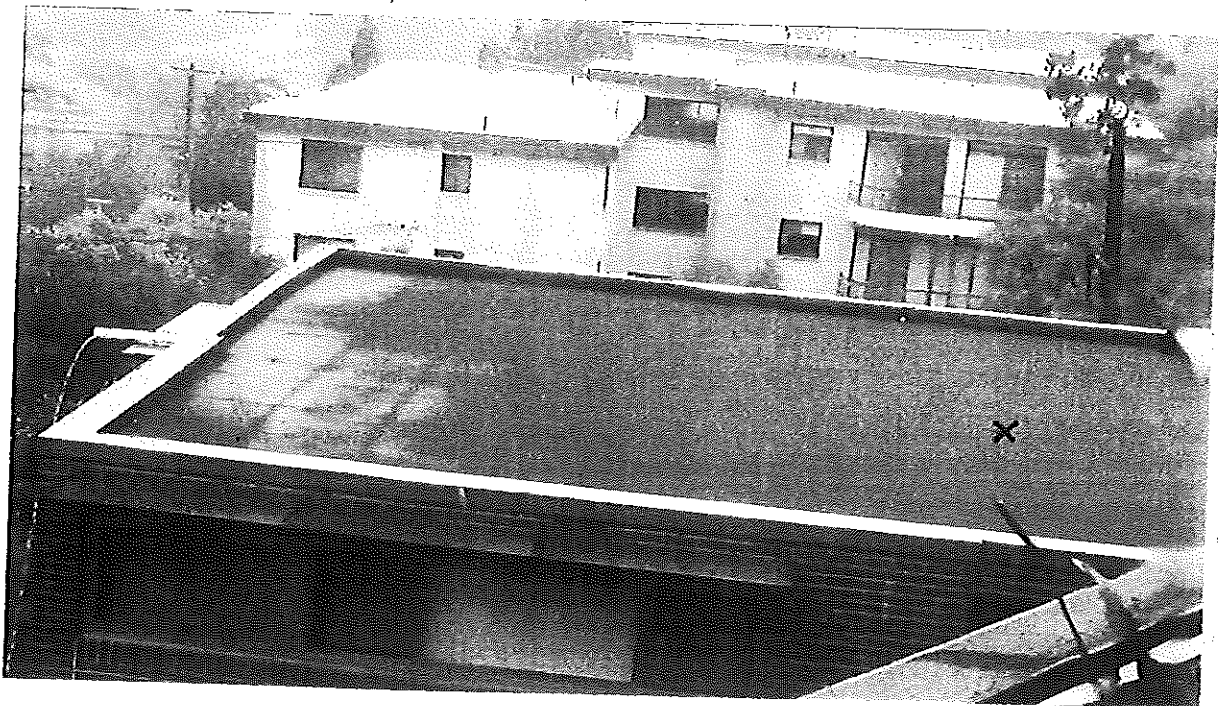
Shows how water pools at far end  
X indicates the only drain on this roof  
water does not flow towards the drain.

Temporary pipe put in by TCQ over (MAY 2016)  
a month ago, creates a waterfall effect,  
onto the rail and deck of Unit 1 and the  
sound created by the pounding water is  
unacceptable and also damaging the rail  
and deck.

Waterfall 11/6/2016

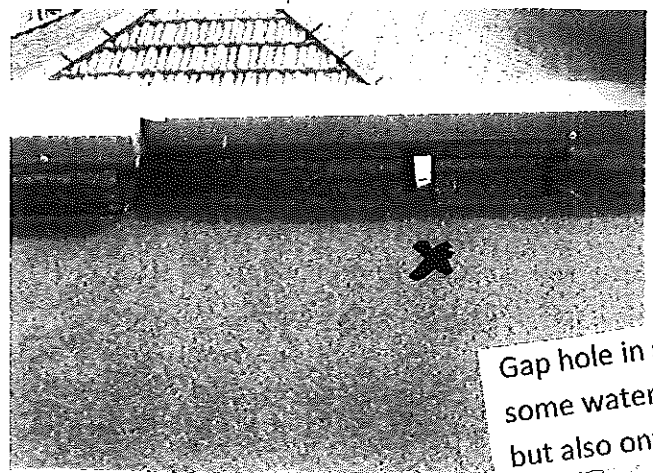
Gap hole in side wall  
some water spills through  
but also onto Deck of Unit 1
