## TERMITE - SITE ASSESSMENT & ADVICE

**Site Address:** 32 Princes Street Hunters Hill NSW 2110

**Report Type:** Pest Inspection Report

**Date of Inspection (s):** 25/10/2021 & 28/10/2021

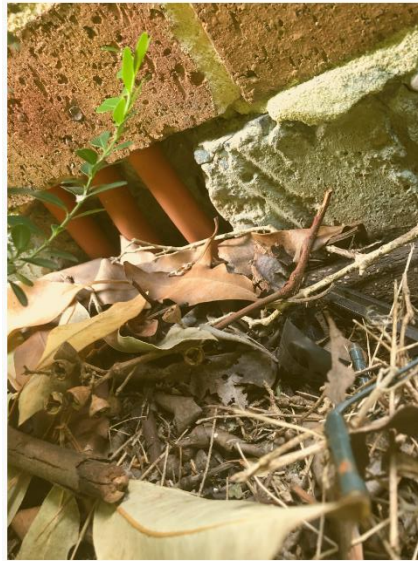
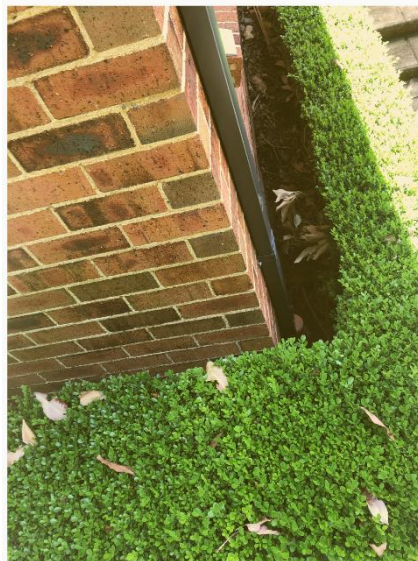
22. Over the Southern elevation of the home where the garden bed is also concealing the concrete slab and brick course junction allowing a concealed entry point for termites into the cavity.
23. Within the rear elevation/Southern wall Due West, the pavers beneath the clothesline should be lowered to expose or express the concrete floor of the house and first course of brickwork to eliminate any concealed entry points into the cavity walls of the home.

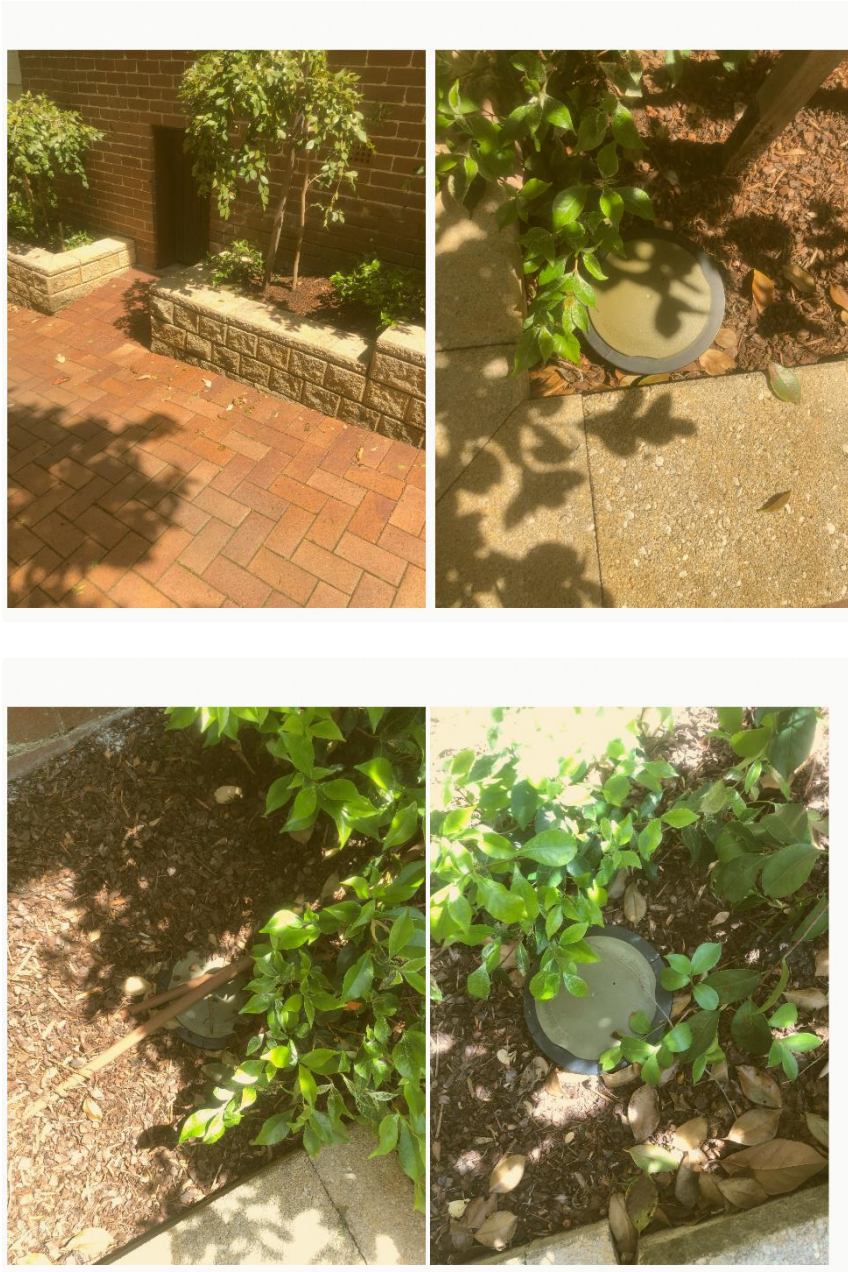
41. In talking with the rear neighbour, she confirms that she has bait stations located around her property which I sighted, and she has a pest inspection carried out every three months, this is consistent for a property that is of high risk nature.
