# INDEPENDENT EXPERT BUILDING DEFECTS REPORT

## 283–289 Blaxland Road, Ryde NSW

**Strata Plan:** SP 92028

**Purpose:** Assessment of alleged defective and incomplete building work

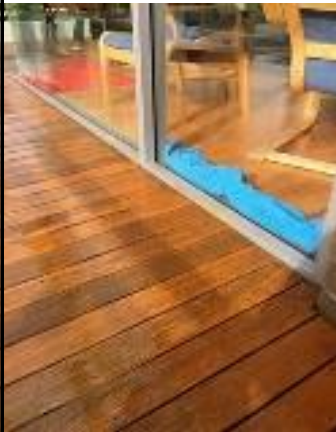
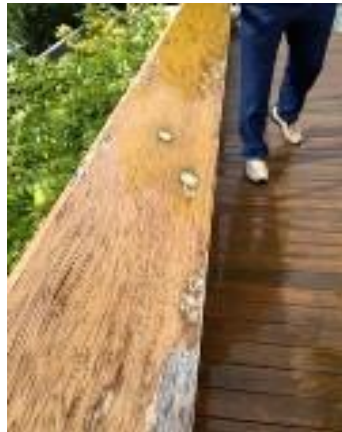
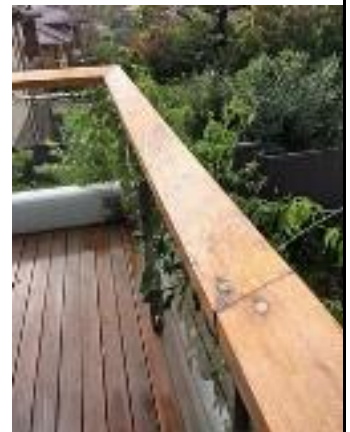
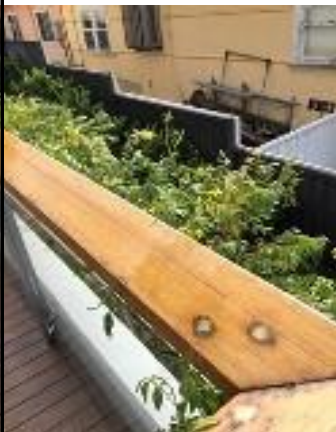
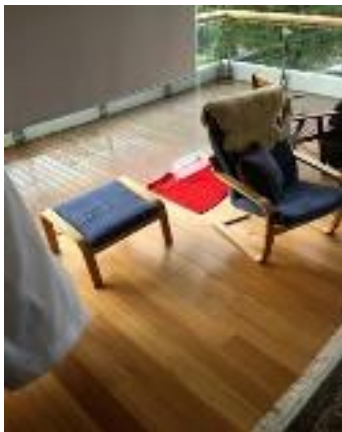
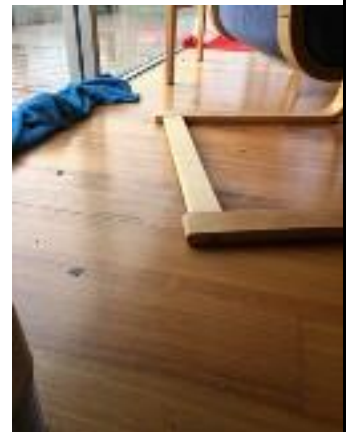
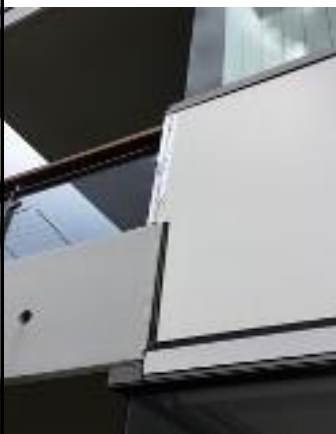
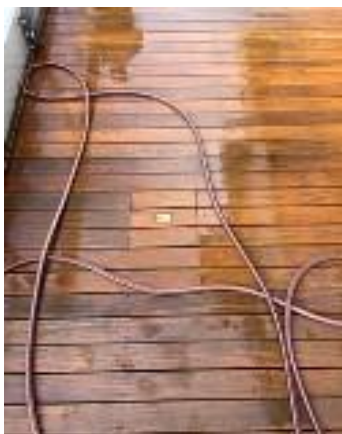
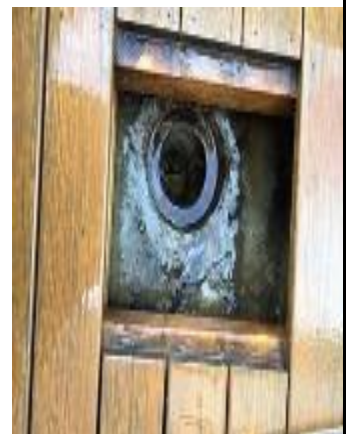
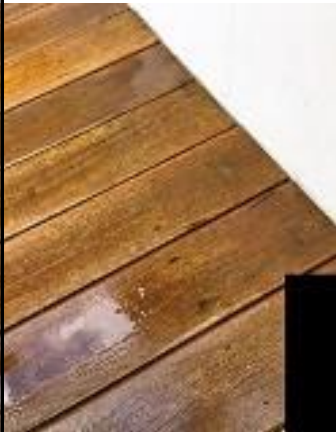
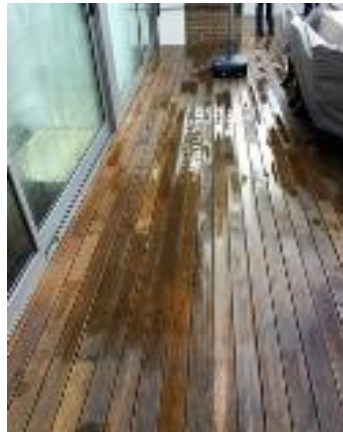
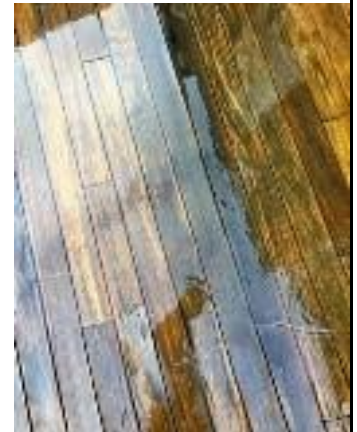
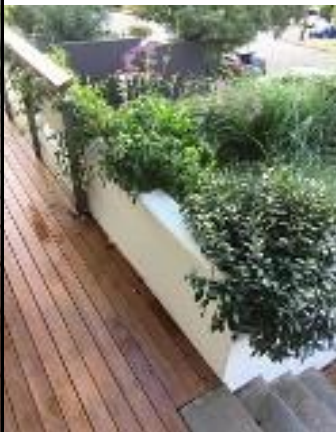
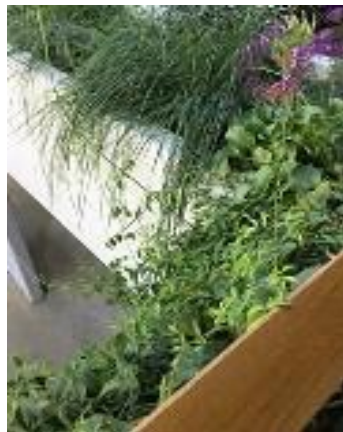
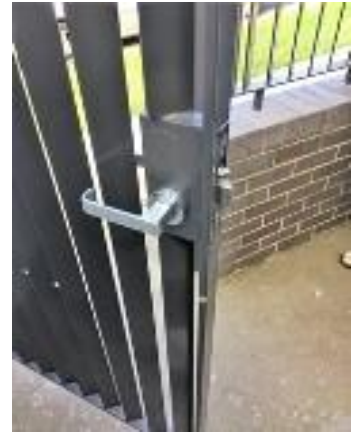
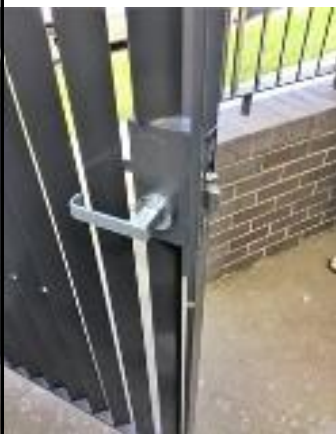
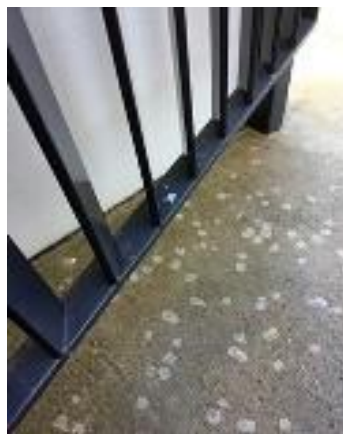
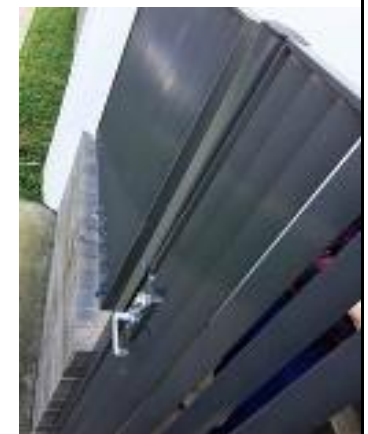
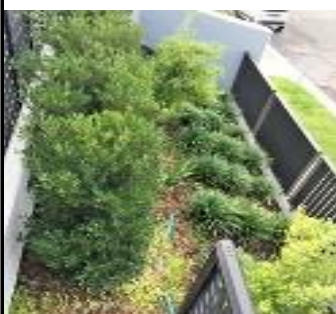
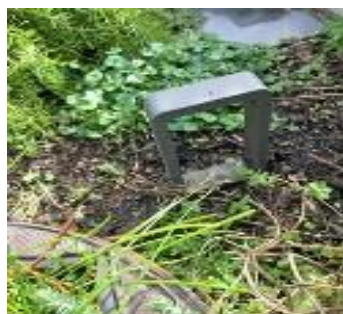
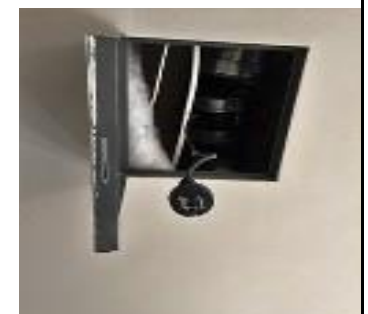
| LOCATION | Lot 4 - 283-289 Blaxland Rd Ryde |

| DEFECT DESCRIPTION & No: 1 | 1. Air conditioning control switch does not allow the bedrooms and living rooms to be individually switched and zoned for the bedrooms and living rooms nor combined as one zone |
| | 2. Bedrooms air conditioning system takes up to 45 minutes to have the temperature within this space brought to an acceptable condition |
| | 3. Living room and kitchen combined spaces take up to 1-1.5 hrs to have the temperature within this space brought to an acceptable condition |
| | 4. Air conditioner compressor tested and the maximum heat output recorded at the internal grills was 21 degrees |
| | 7. Garden lights missing and the existing lights not working within garden beds |

| | 9. Rear gate to Kulgoa Rd, lock not functioning correctly ( Locked by key from the external face only ), No cylinder provided on the property side of the gate to allow the gate to be locked or unlocked from the inside, powdercoating chipped and damaged, gate and post out of wind. |
| | 10. The stainless handrail along the external rear stairs leading to Kulgoa Rd are defected with chipped powdercoating, flaking powdercoating, rusted stainless fixtures and fittings |
| | 11. Rear deck has cupping and loose decking boards, they are nailed down, best building practice would see the decking screwed down. |
| ACTIONS REQUIRED For Defect No: | 1-4. We suspect the air conditioning system has been poorly designed and installed. We suspect the ducting doesn't meet manufacturers instructions and the compressors inspected may be undersized for the volume within each apartment |

| | 1-4. We recommend an Independent Consultant assess and test the entire air conditioning system for the following results |
| | <b>CAPACITY OF THE</b> : Compressor used against the size of this apartment, ducting size used and connections, number of dampers used and their current function and capacity, airflow output hot & cold, zoning function capacity to have all internal spaces conditioned or bedrooms and living rooms separately zoned |
| | Once the assessment and tests are complete a "Scope of works" will be confirmed to make the air conditioners suitable for the apartment - Note the Scott Schedule is solely addressing the investigation works required to obtain a scope of works to remedy the problem within this apartment |
| | Repair and make good the water entry points within the walls and window junctions, and within the window suites |
| | Plasterer to repair and make good the internal plasterboard within the master bedroom |

| | Plasterer to patch and make good the damaged ceiling due to the new exhaust fan installed |
| | An electrician to supply and install the missing light fittings within the garden beds |
| | 10. Supply and install new stainless steel handrail along the external wall and stairs together with new fixture and fittings |

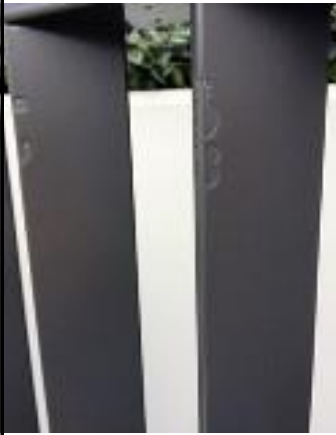
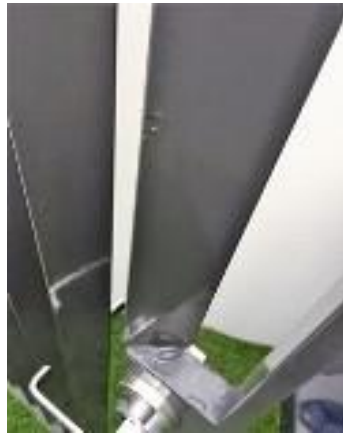
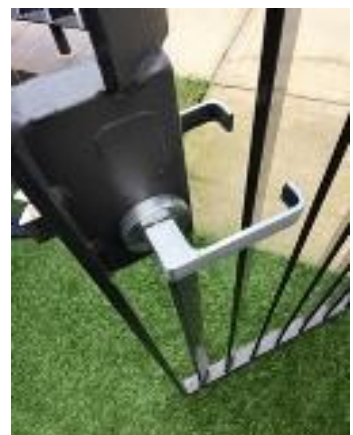
| LOCATION | Lot 5 - 283-289 Blaxland Rd Ryde |

| DEFECT DESCRIPTION & No: 1 | 1. Air conditioning control switch does not allow the bedrooms and living rooms to be individually switched and zoned for the bedrooms and living rooms or combined as one zone |
| | 5. The entry gate and boundary fence ( Powdercoated steel ) is chipped and rusted, the powdercoating is flaking off the gate, fence and posts, plus the metal has been glued and not welded together. |
| | 6. Soil and landscaping is in contact with the front deck, wet and dry rot will develop over time if left as is. |

| ACTIONS REQUIRED For Defect No: | 1-4. We suspect the air conditioning system has been poorly designed and installed. We suspect the ducting doesn't meet manufacturers instructions and the compressors inspected may be undersized for the volume within each apartment |
| | 1-4. We recommend an Independent Consultant assess and test the entire Air conditioning system for the following results |

| | <b>CAPACITY OF THE</b> : Compressor used against the size of this apartment, ducting size used and connections, number of dampers used and their current function and capacity, air flow output hot & cold, zoning function capacity to have all internal spaces conditioned or bedrooms and living rooms separately zoned | | | | | | |
| | Once the assessment and tests are complete a "Scope of works" will be confirmed to make the air conditioners suitable for the apartment - Note the Scott Schedule is solely addressing the investigation works required to obtain a scope of works to remedy the problem within this apartment | | | | | | |

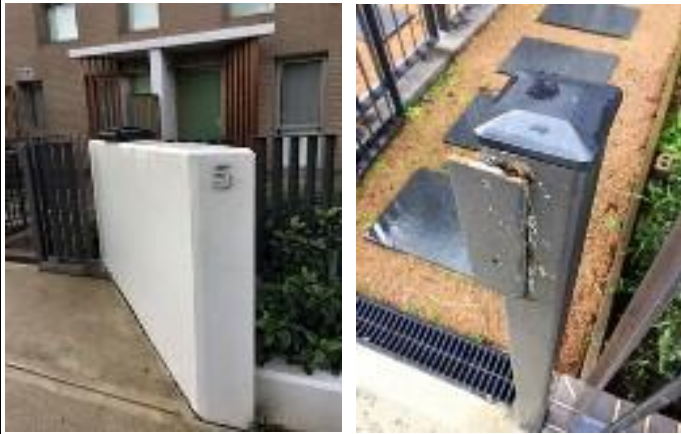
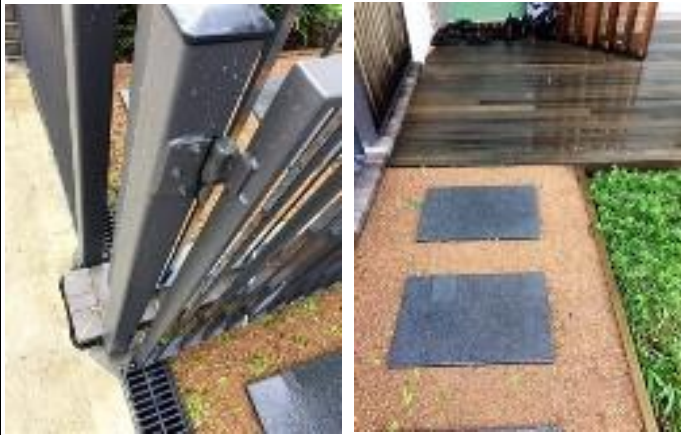
| LOCATION | Lot 6 - 283-289 Blaxland Rd Ryde |

| DEFECT DESCRIPTION & No: | 1. Air conditioning control switch does not allow the bedrooms and living rooms to be individually switched and zoned for the bedrooms and living rooms nor combined as one zone |
| | 5. The entry gate and boundary fence ( Powdercoated steel ) is chipped and rusted, the powdercoating is flaking off the gate, fence and posts, plus the metal has been glued and not welded together |
| | 6. Soil and landscaping is in contact with the front deck, wet and dry rot will develop over time if left as is. |

| ACTIONS REQUIRED For Defect No: | 1-4. We suspect the air conditioning system has been poorly designed and installed. We suspect the ducting doesn't meet manufacturers instructions and the compressors inspected may be undersized for the volume within each apartment |
| | 1-4. We recommend an Independent Consultant assess and test the entire air conditioning system for the following results |
| | <b>CAPACITY OF THE</b> : Compressor used against the size of this apartment, ducting size used and connections, number of dampers used and their current function and capacity, air flow output hot & cold, zoning function capacity to have all internal spaces conditioned or bedrooms and living rooms separately zoned |
| | Once the assessment and tests are complete a "Scope of works" will be confirmed to make the air conditioners suitable for the apartment - Note the Scott Schedule is solely addressing the investigation works required to obtain a scope of works to remedy the problem within this apartment |

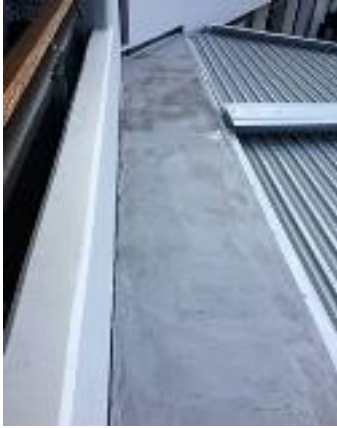
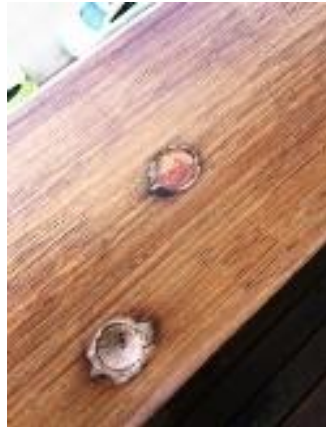
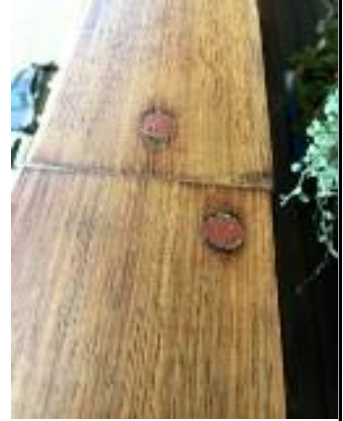
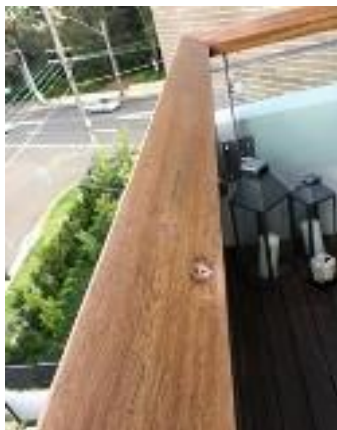
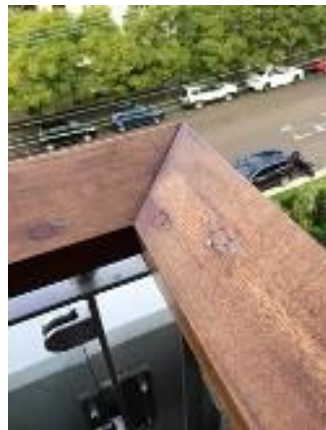
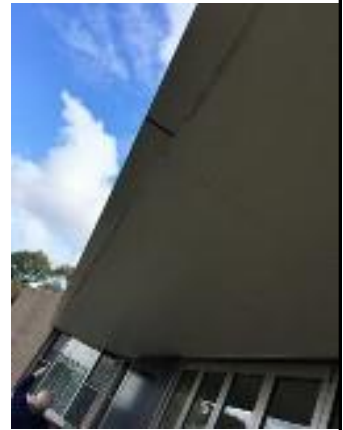
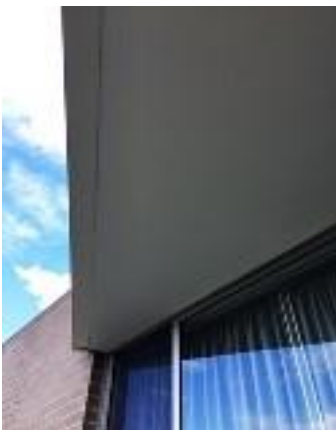
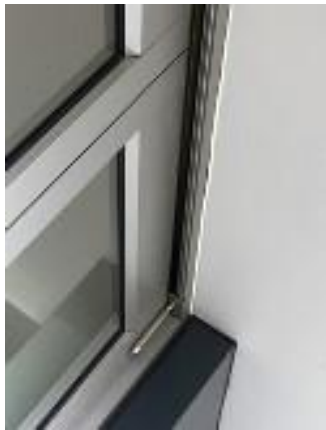
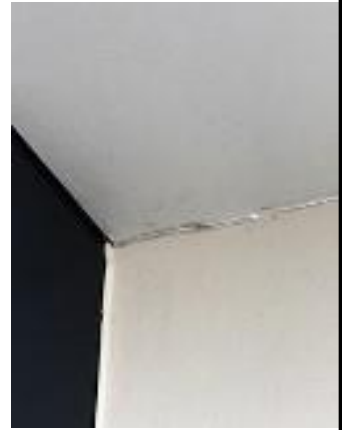
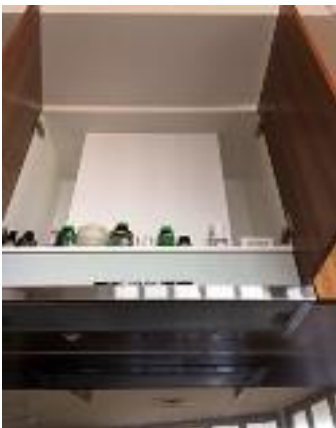
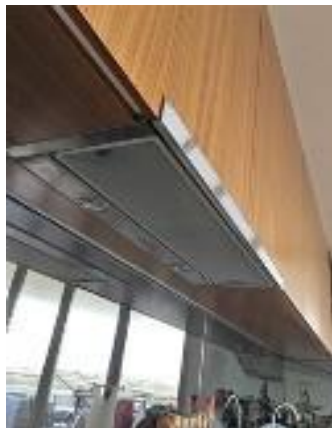
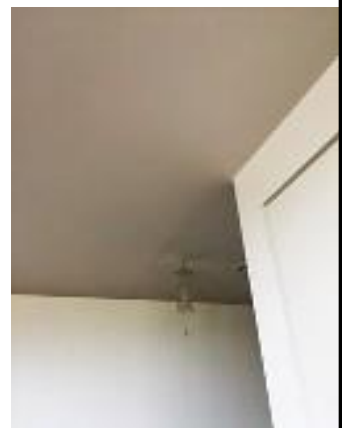
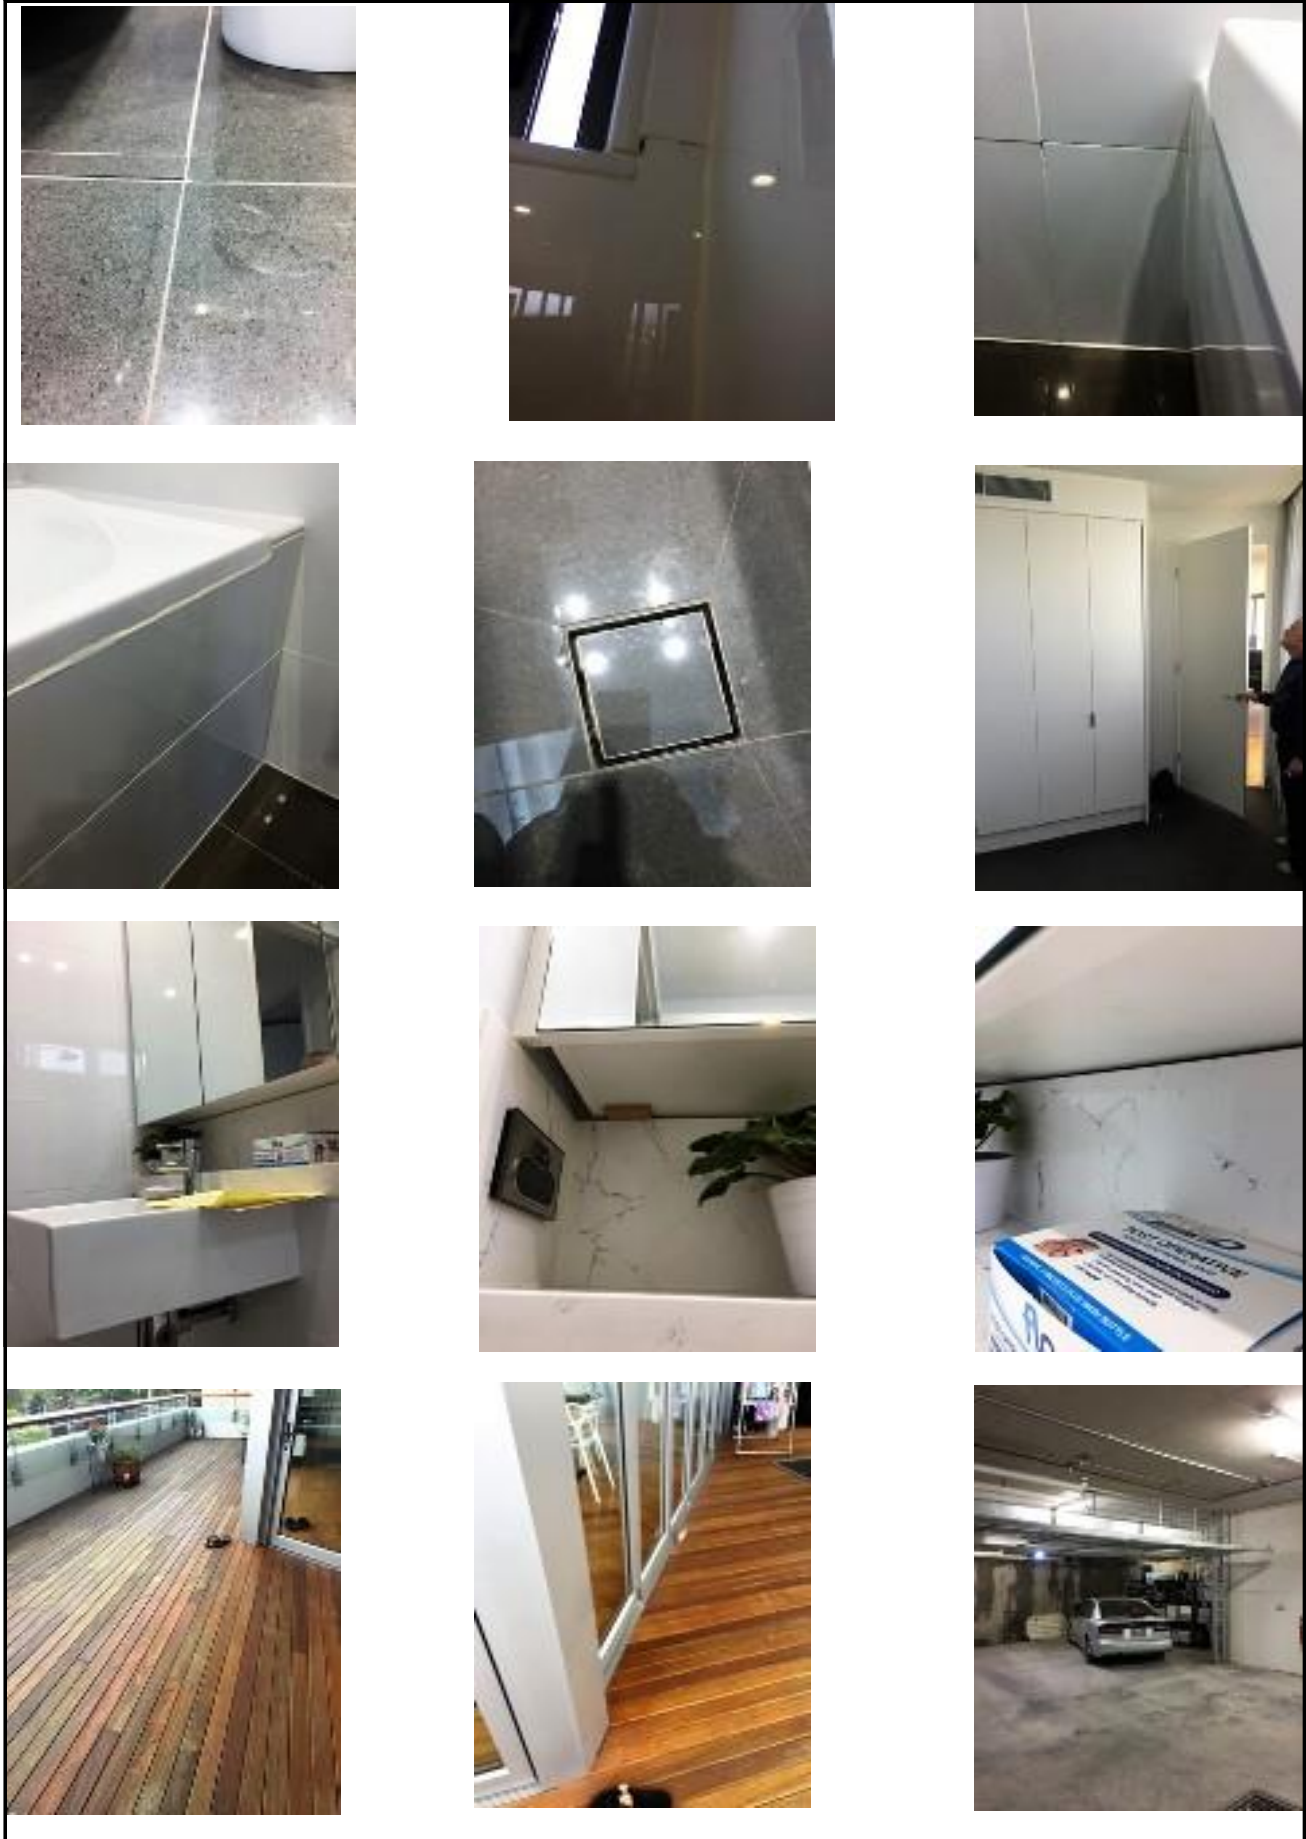
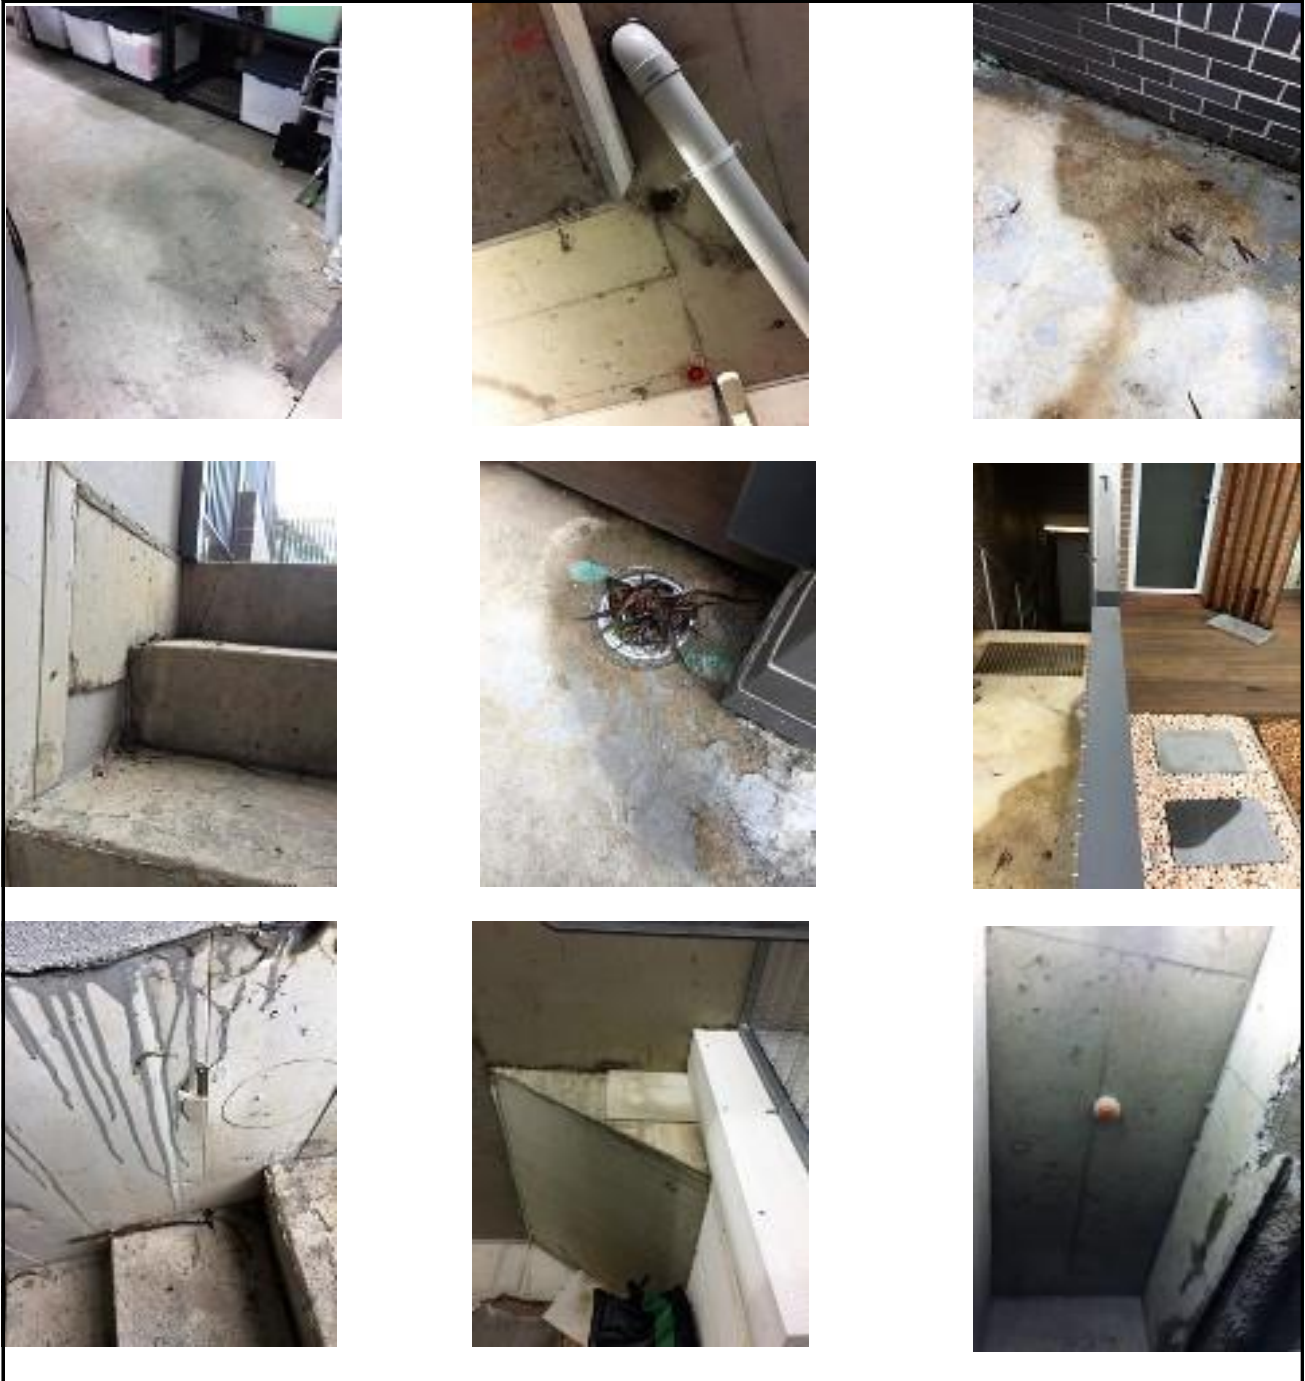
| DEFECT DESCRIPTION & No: | 1. Air conditioning control switch does not allow the bedrooms and living rooms to be individually switched and zoned for the bedrooms and living rooms nor combined as one zone |
| | 5. External balcony handrail is poorly complete and the timber handrail sealant is defective and the timber is breaking down, plus the timber is discolouring and the timber putty is recessed and sunken below flush to the adjacent timber surfaces |
| | 6. The external soffit lining within the outdoor balcony is cracked and damaged and in need of repair and re-painting, together with control joints installed between the wall and soffit lining junctions |
| | 7. The external decking boards are cupping and loose underfoot, the decking boards on the balcony are inconsistent in colour due to poorly applied and inconsistently applied sealant to the timber members. The timber decking boards are in direct contact with the external walls of the apartment with no weep holes expressed nor seen within the rendered external walls |
| | 8. Existing toy room has a skylight that is leaking |

| | 9. The internal timber floor boards within the kitchen, living room, dining and hallway are drummy and loose underfoot. The Floor boards are stained by water entry within the master bedroom where the floor meets the ensuite. The timber floor doesn't appear to be equally adhered to the concrete substrate, the bedroom floor needs to be raised by approx. 40mm from the living room finish floor level or 20mm within the bedroom itself |
| | 11. Master bedroom wall linings below the window are defective and affected by moisture and imperfections within the plasterboard wall linings |
| | 13. Ensuite floor will need to be raised to match the new finished floor level within the bedroom ( approx. 20mm raised ) This is signs that moisture is leaking out of the bathroom and the timber floor boards are stained and defective ) The bathroom bidet needs to be sealed where the bidet and wall tiles meet. The toilet seat is broken and in need of replacement, the existing wall and floor tile junctions are not sealed with flexible sealant. The window winder is rusted and in need of a new window winder chain |
| | 15. Within the garage there is a leak within the overhead concrete slab, leaking within the centre of the garage. The light fitting holds water and the light fitting is not working |
| | 16. The storage cage and face fixed screw heads are rusted, the fixings and steel framing and mesh is rusted. I could see old water stains at the base of the floor and wall junction, I could smell damp and mould in this area at the time of my inspection |

| ACTIONS<br>REQUIRED For<br>Defect No: | 1-4. We suspect the air conditioning system has been poorly designed and installed. We suspect the ducting doesn't meet manufacturers instructions and the compressors inspected may be undersized for the volume within each apartment |
| | 1-4. We recommend an Independent Consultant assess and test the entire air conditioning system for the following results |

| | 7. The timber decking boards on the balcony need to be re-fixed with screws and the deck needs to be sanded and re-stained for an equal finish in colour and sealant applied to the timber decking boards, and the decking boards need to be cut back so they are not in contact with the external wall nor blocking the external wall linings / weep holes that allow water to egress from the weep holes / cavity wall |
| | 11. The master bedroom skirting and plasterboard affected by moisture and imperfections need to be removed and replaced with defect free material and painted finish |
| | 15. Remove the garden bed and timber deck fixed down to the concrete slab above this apartments garage roof, waterproof the garden slab prior to reinstalling the garden within the garage, where there is a leak within the overhead concrete slab, leaking within the centre of the garage. The light fitting holds water and the light fitting is not working. |
| | 16. Remove all rusted screws and apply cold galvanize to all rusted steel members |

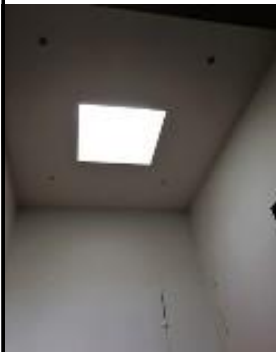
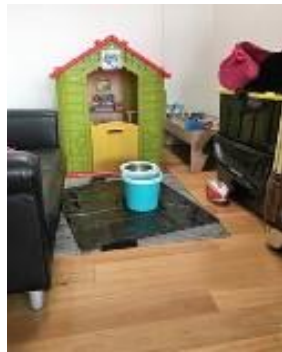
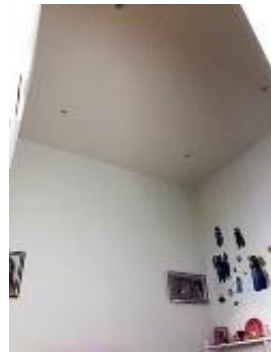
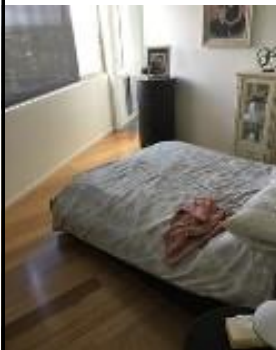
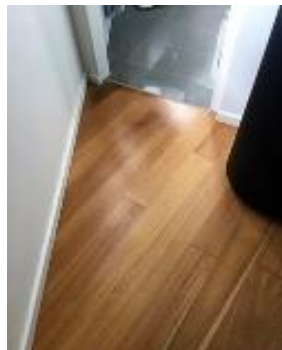
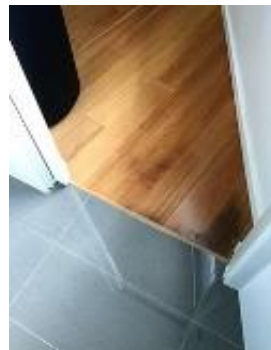
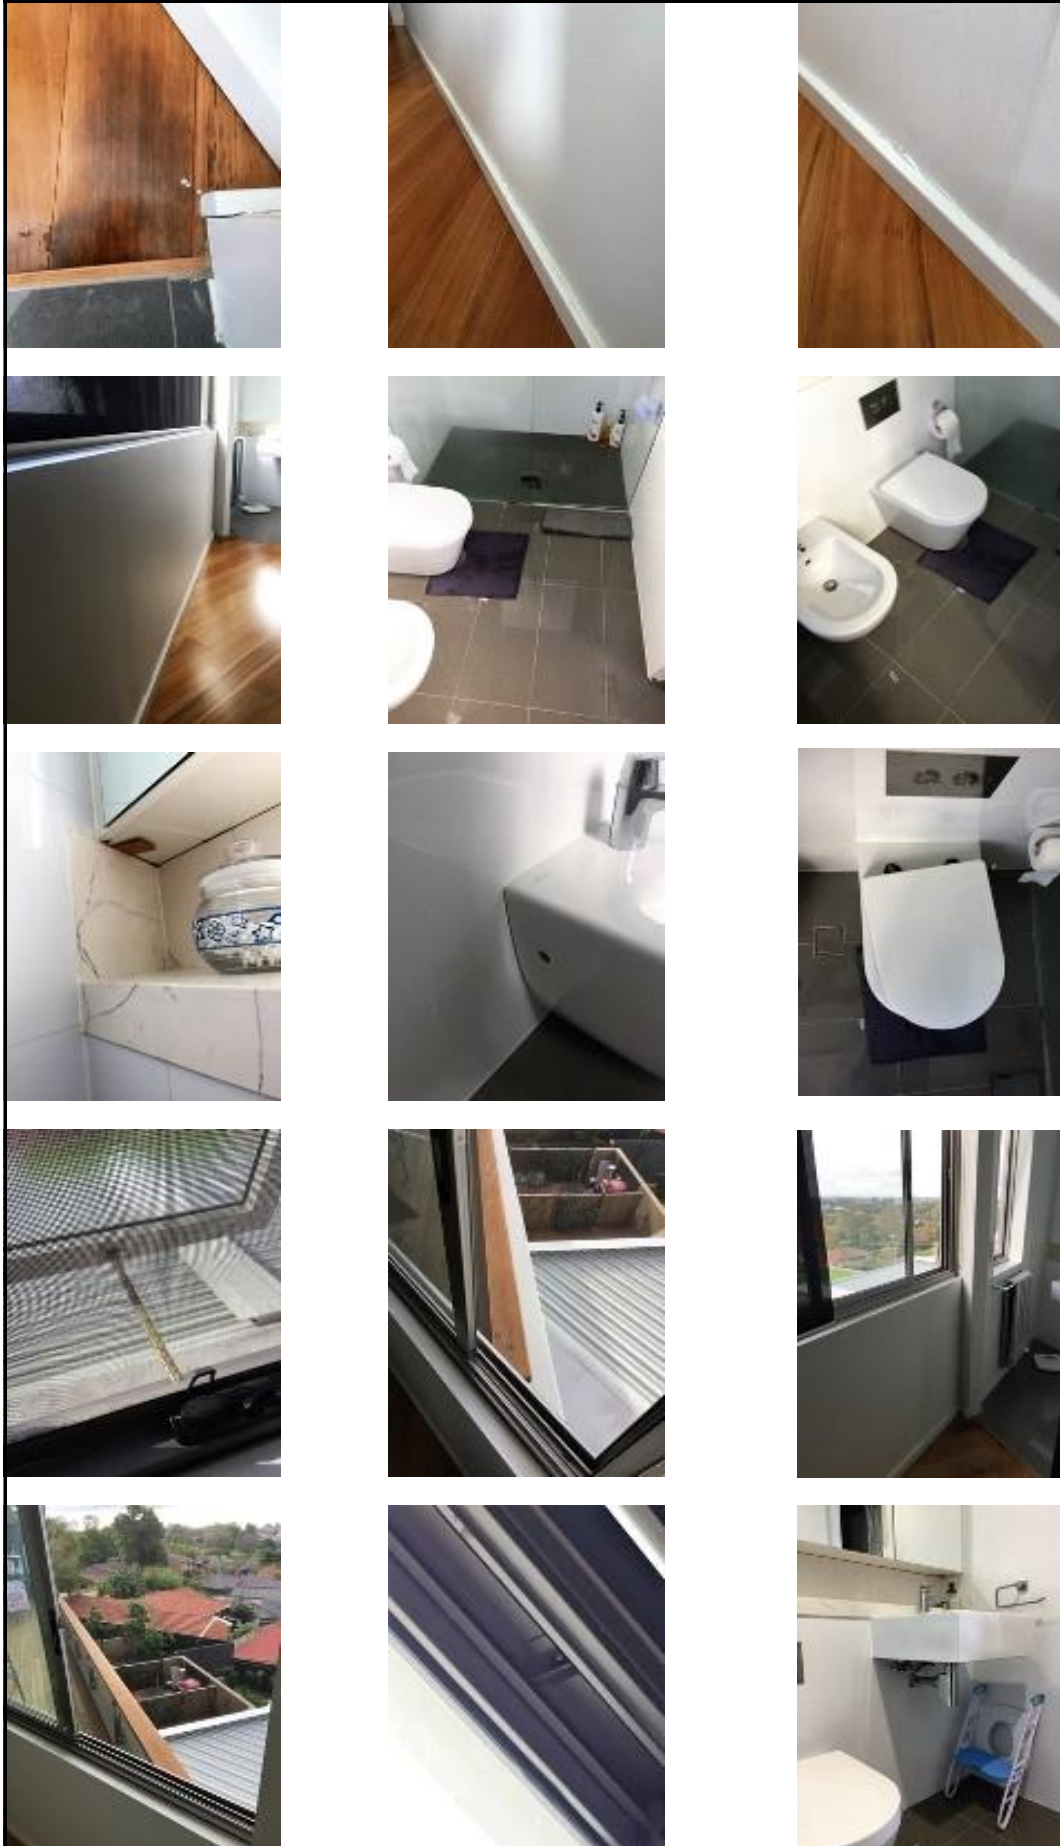
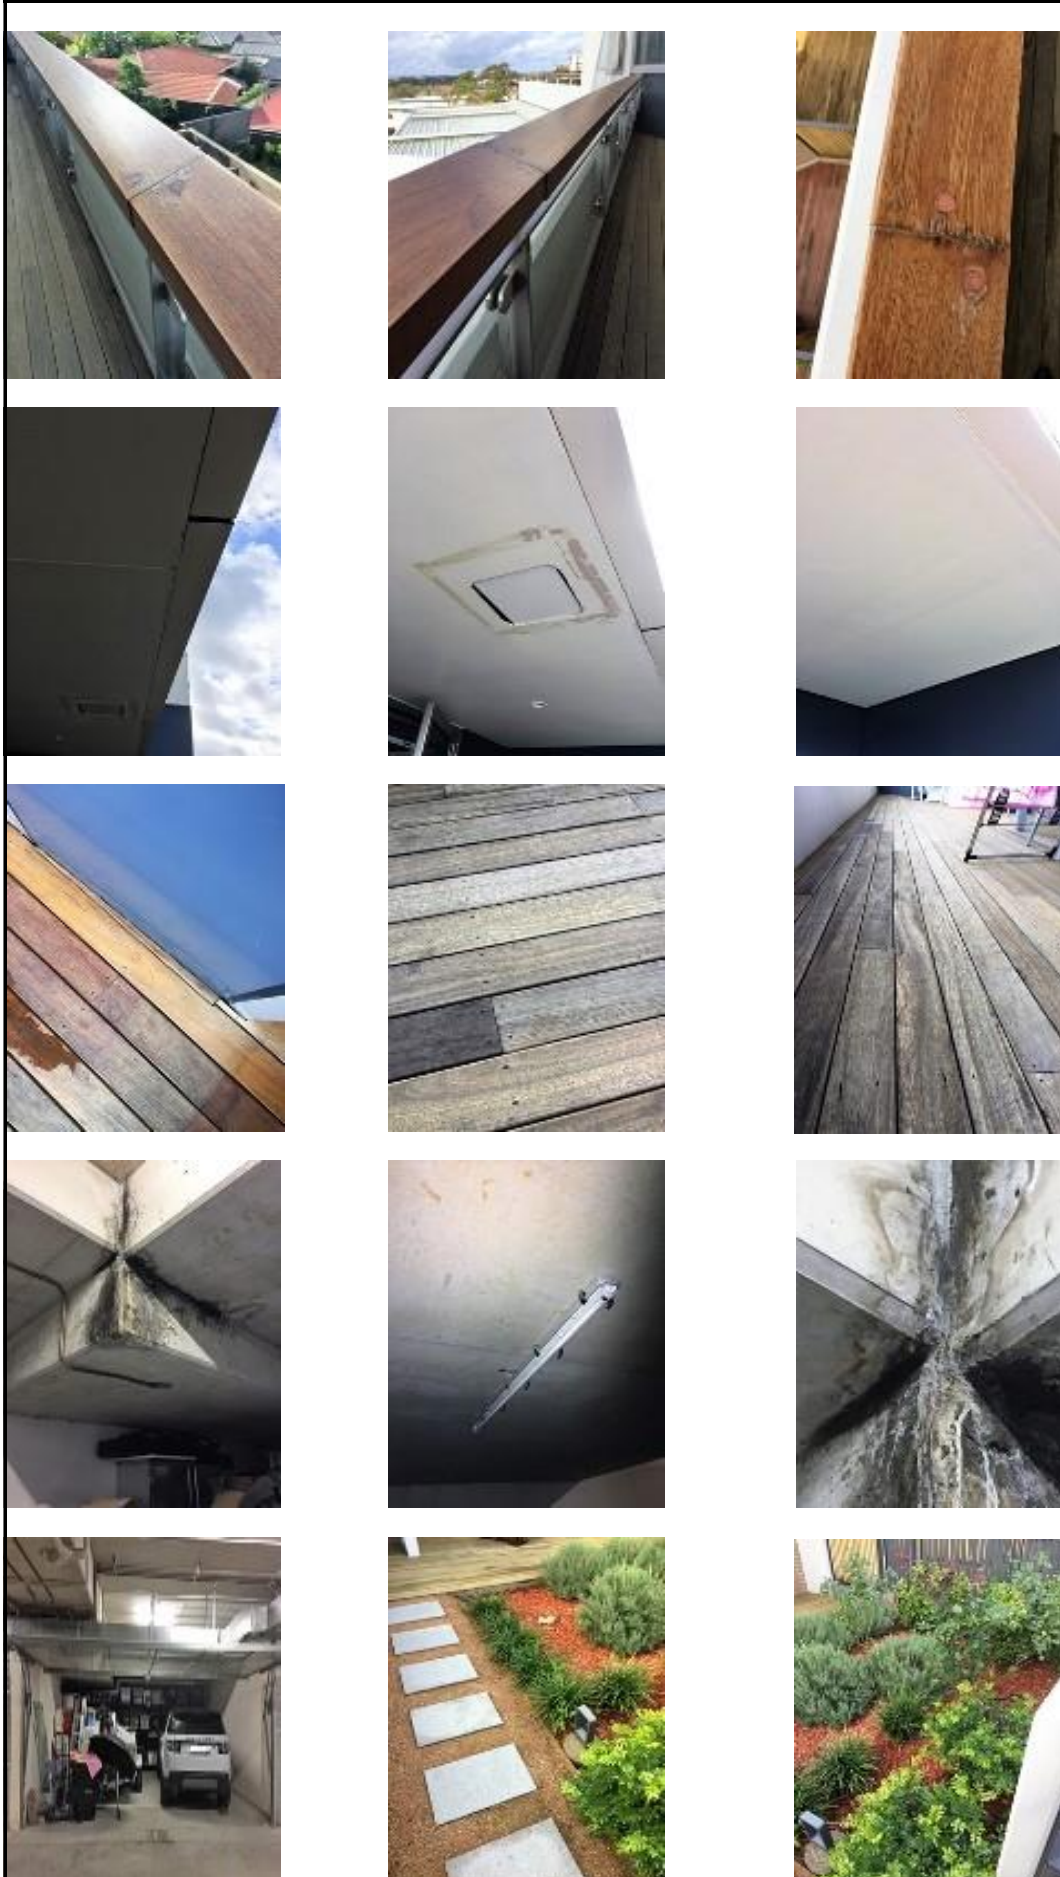
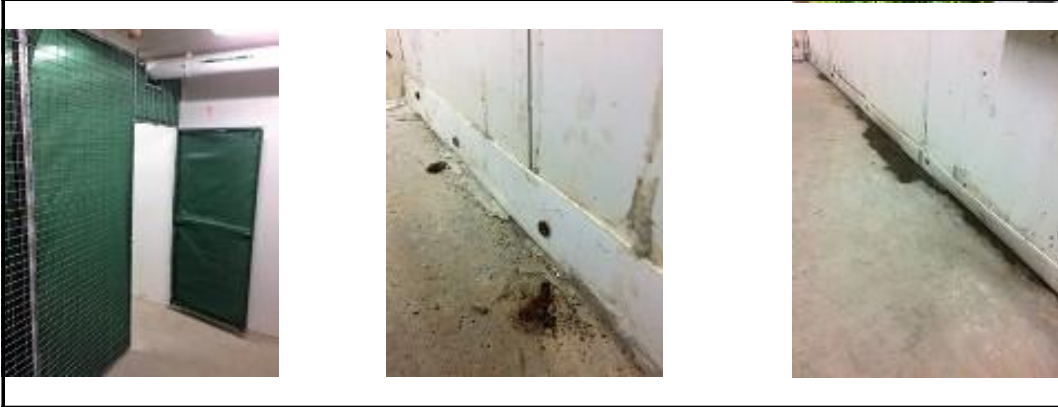
| ROOM NAME | External deck, glass balustrading, soffit linings, timber decking boards, Fascia and cladding water entry, floor wastes on the deck, kitchen cupboards, Skirting, Internal floor boards, bathroom tiles and grout, living room bifold doors and door hardware |

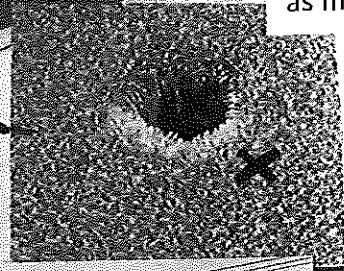
Enlarged view of drain hole  
as marked X in picture 34
